LEVEL 2

Your survey report

Property address

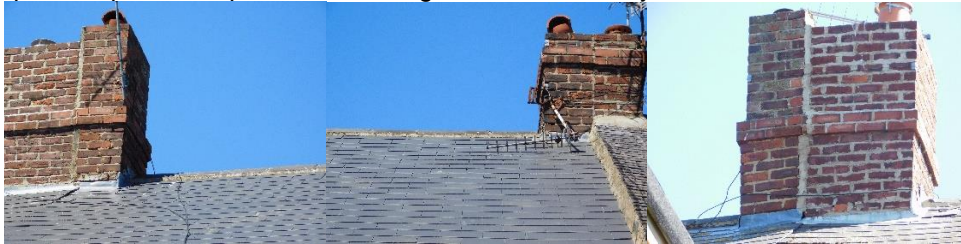
The chimney structures are leaning. A common cause for a leaning chimney is from the expansion of eroded mortar joints. If the surface of the chimney stack is exposed to the prevailing wind, constant wetting can result in the expansion of mortar joints and one side drying out quicker than the other side, thereby causing the stack to lean away from the wind. The stack should be assessed by a qualified and experienced competent person.

The pointing will need to be checked to ensure the correct depth has been achieved, as surface pointing is prone to cracking and becoming loose. Loose and missing pointing has the potential to allow water ingress into the property.

There were several bricks that had blown/de-faced. The bricks will need replacing by a suitability qualified person to prevent water ingress and instability of the structure.

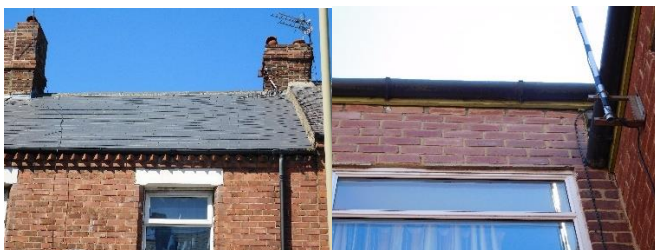
D2 Roof coverings

The roof is a mid-terrace pitch design and is completed with a wet ridge and slate to the main roof pitch.

Mortar to the ridge tile was cracked. Cracked mortar to the ridge tile can compromise the tile seating, resulting in water ingress into the roof structure. Unseated tiles can damage the roof pitch covering and structures below the roof line.

Timber fascias to the rear of the property appear untreated and twisted

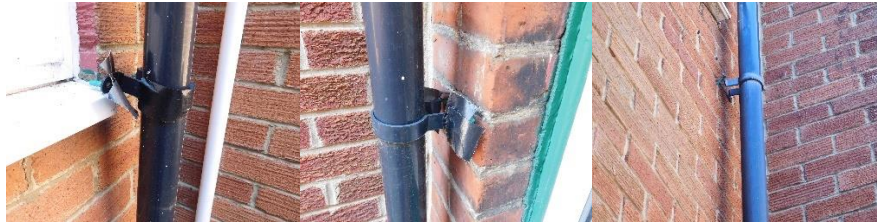
During the inspection the weather was mainly dry and due to the height restrictions, the rainwater goods were not comprehensively checked. The rainwater components will need to be regularly inspected to ensure rainwater is discharged correctly into a downspout. Gutter unions and stop ends gasket seals are prone to perish and the gutter channel/trough can be blocked or reduced water flow by vegetation or a build-up of a silty spoil. A defective rainwater system can cause internal damp.

To the rear the two downspouts have become detached from the property as the clips have failed. The downspouts will need to be refixed using the correct downspout bracket.

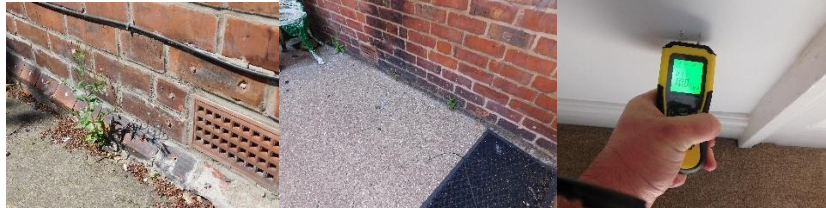
D4 Main walls

The main walls are in satisfactory structural condition, with no signs of significant cracking, settlement or other structural movement to the property. Condition rating 1. As foundations cannot be inspected without excavation I cannot comment on their construction, depth or condition.

The mortar between the bricks is generally weathered. Condition rating 1.

The walls of properties of this age usually have a barrier against dampness from the ground (a feature usually called a damp-proof course or DPC). The damp proof course is not visible but likely to be formed using bitumen. Condition rating NI. There are an adequate number of air bricks to ventilate the sub floor void. Condition rating 2.

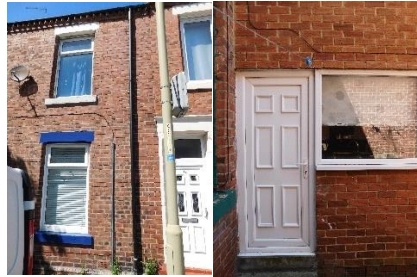
D5 Windows

The replacement windows are UPVC with double glazed panes. They are dated and whilst no significant defects were observed, budgetary allowance should be made for their early renewal. Condition rating 2. It should be noted that double glazing can vary in quality, particularly in respect of the seals around the edges of the glass. Whilst no such problems were found, these seals tend to deteriorate over time, eventually resulting in misting and the need for repair or replacement. This may only be visually apparent at certain times depending on several factors such as temperature and humidity

Due to changing atmospheric conditions, it cannot be determined if the double-glazed units have failed which creates condensation/misting within the internal air gap pane of glass. During the inspection I did not see any misting/condensation within the double-glazed units

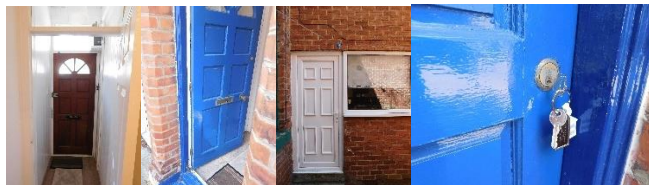
D6 Outside doors (including patio doors)

The front door is timber with glazed panes. It is dated and showing signs of deterioration. On accessing the property, the Yale lock was found to be stiff and awkward to operate. There is also a 5-lever mortice lock installed but no key was present at the time of survey, budgetary allowance should be made for renewal. Condition rating 2.

The external replacement rear door is UPVC. It is dated and whilst no defects were observed, budgetary allowance should be made for eventual renewal. Condition rating 1. Your legal advisor should confirm that this work has a transferable guarantee. Please also see section I2.

It is advisable to install a door deflector to the bottom rail of the door. A deflector projects rainwater away from the threshold, which helps to reduce the door casing ends from becoming saturated and leading to timber decay.

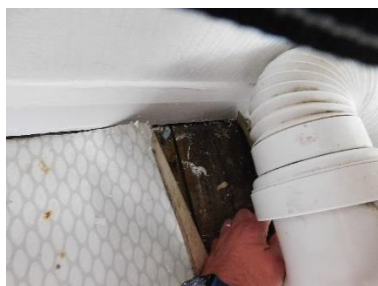
E4 Floors

The ground floor is a suspended timber floor.

The timber floors appeared flat and free from excessive spring and deflection other than what would be expected for a property of this age. Floor timbers can be weakened or damaged by the introduction of services such as electric cables and pipe work etc. Therefore, when timbers are exposed, the opportunity should be taken to check the timbers and repair as found necessary. The floors should be capable of bearing normal domestic loads. Condition rating 1

Slight movement and deterioration of the floorboard behind the WC was noted, this is likely to have been caused by a Historic leak. On testing the WC does not appear to be leaking at present.

Air vents are required at two metre intervals to allow cross ventilation of a suspended ground floor. Additional air vents may be required to prevent humidity beneath the suspended floor.

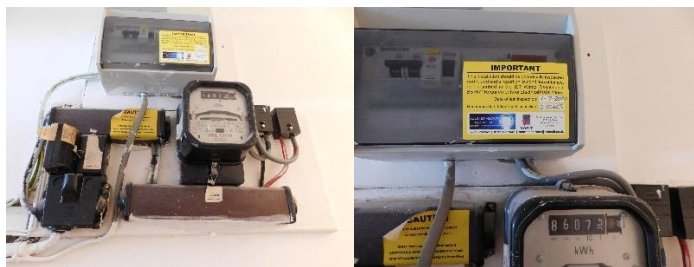
There was no electrical certification available at the time of our survey. Due to the potential of serious harm and injury resulting from an electrical fault, the condition report has been scored as a three.

The score is to emphasise the importance of obtaining a current electrical certificate from an electrician registered with a competent person scheme. A competent person can also provide a condition report of the remaining service life of the system and provide costings for any remedial works.

You should ask the current owner for recent copies of any available test certificates. The electrics should be tested every ten years for an owner-occupied home, and every five years for rented property.

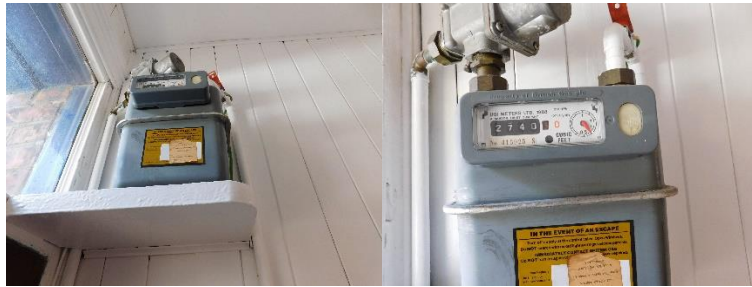
F2 Gas/oil

We have not tested the gas and heating system and cannot confirm its condition. (Please refer to the service limitations to inspection) It is advisable to install a carbon monoxide tester to every room with a gas appliance. It is also advisable to test the detector on a regular basis.

There was not a gas safe certification available at the time of our inspection. Due to the potential of serious harm and injury resulting from a gas fault or carbon monoxide poisoning, the condition report has been scored as a three. The score is to emphasise the importance of obtaining a current gas safe certificate. All gas-enabled appliances and all gas fittings must be checked.

A competent person can also provide a condition report of the remaining service life to the system and provide costings for any remedial works, prior to the exchange of contracts.

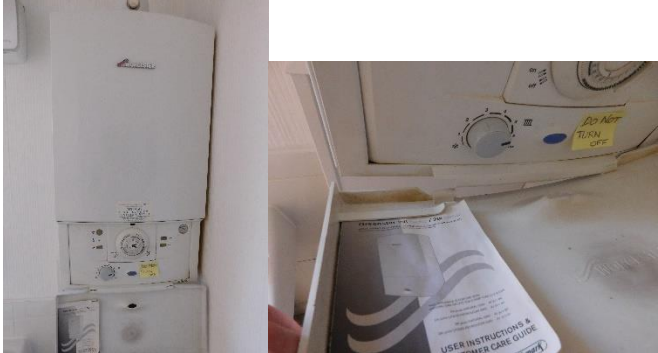
F4 Heating

<p>Heating is provided to the property by a combination condensing boiler. The boiler was located in the bathroom. The control access panel is damaged and does not latch correctly.</p> <p>The heating to the radiators was not on at the time of the survey.</p> <p>The heating comprises of a traditionally pumped hot water system with radiators linked by copper/plastic pipes.</p> <p>We have not undertaken any tests of the system and cannot comment on its full working order.</p> <p>We are not aware of a current test certificate for the heating system.</p>
