# Your survey report

Property address: [REDACTED]

Inspection date 17/10/2024

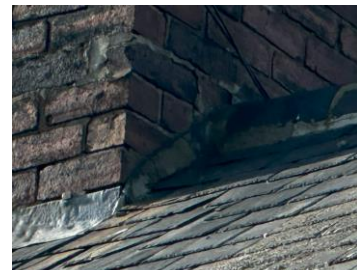
Pic 7: missing lead work saddle

It appears from the ground level that the saddle flashing is missing. Lead work to a chimney stack structure protects the masonry from becoming saturated and forms a watertight junction between the roof covering and chimney stack structure.

It is advisable to appoint an approved and reputable roofing contractor to assess the entire chimney stack to provide repair costs, and to provide additional recommendation to any masonry repairs.

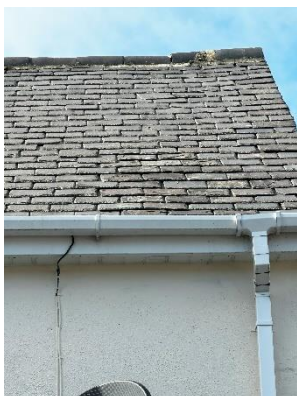
Pic 8: mis aligned ridge tiles

The roof covering has a deflection, there are areas of ridge tiles that are not aligned and seated to the pitch correctly (slight uplift to the tile). Tiles that are not seated correctly can allow wind driven rain into the roof structure which can result in water damage. The tiles should be checked for watertightness.

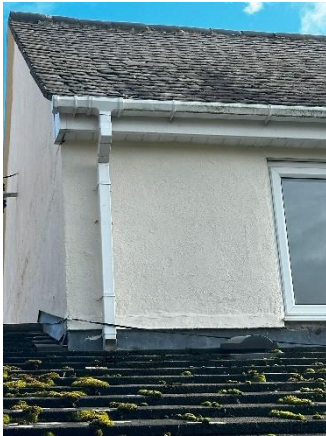
Pic 11: Moss and algae

Moss and algae are beginning to form on the roof pitch, this is a relatively maintenance issue. However, the roof pitch will need to be cleaned in the future with a suitable moss and algae treatment. Moss can hold water, and when frozen can damage the surface of the roof pitch covering over time. Moss can also reduce ventilation which can increase condensation within the roof space.

It is advisable to appoint a reputable roofing contractor that is registered with the National Federation of Roofing Contractors or an approved governing body to assess the entire roof covering (including elevations and extensions) condition, ventilation, repair costs and remaining product/material lifespan before the exchange of contracts.

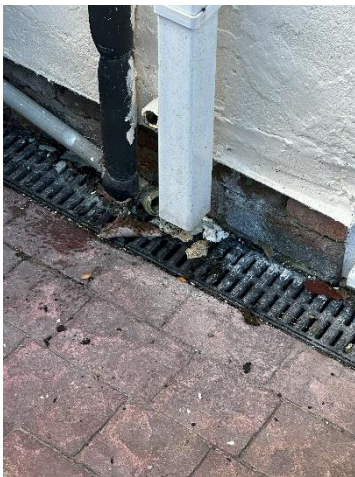
Pic12: down spout cut short of gulley

The downspout is not connected to the underground drainage system. A rainwater downspout that is not connected to a drainage system can discharge a considerable amount of water which has the potential to saturate and damage a surface or masonry structure. It is advisable to check for underground drainage and connect the downspout to the drainage system.

Down spouts should pass through the top of the gulley to avoid splashback against masonry

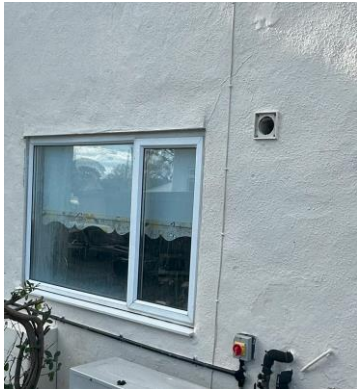
Pic13: Cracking above window head

The render has diagonal crack above the window opening. Diagonal cracking can indicate lintel deflection or structural movement. A lintel supports the masonry above an opening such as a door or window. It is advisable to check the crack does not extend beyond the render and into the masonry further advice from a Structural Engineer regarding the stepped cracking. The Engineer may suggest monitoring or repair works, such as a new lintel.

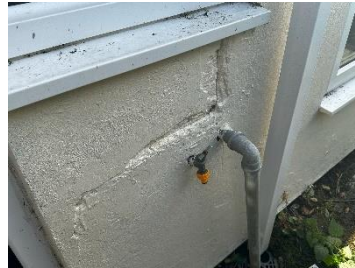
Pic14: Damaged render

The render finish coat has minor cracking to several areas. This cracking may allow water to seep behind the coating which can further loosen or crack the render during inclement weather. The cracked render coating should be surface repaired or removed and then prepared to receive new render. The repair should be carried out by a suitably experienced and qualified person.

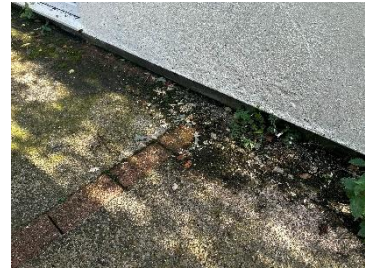
Pic15: DPC breached

The damp proof course (DPC) is not a 150mm above the external levels. The 150mm gap reduces moisture and rainwater splash back above the DPC which can result in saturated masonry and internal damp. Should the walls become damp internally, then the external levels may need to be reduced by a150mm.

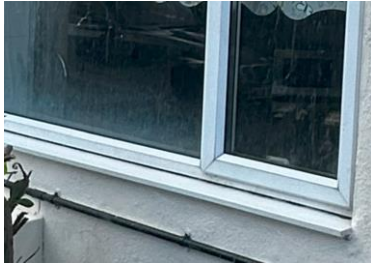
Pic19: External beading

The window frames have external glazing beading which is no longer used in a modern window design. The external beading and double-glazed units can be removed externally. It is advisable to make enquires with the proposed property insurance company, as external glazed beading may be an exclusion from an insurance policy. I would recommend replacing the window frames for property security.

It is recommended to seek advice from a suitably qualified and experienced 'competent person scheme', such as a FENSA window and door installation company to assess the window condition and remaining service life of the windows against repair works.

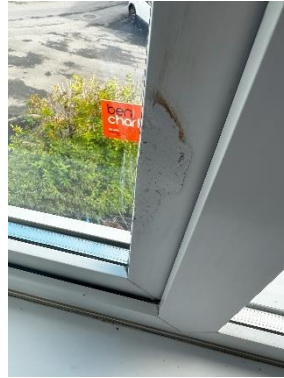
Pic20: Damaged frame

The upvc frame is damaged. The damage will affect the frame structure and components, and this may result in the window being replaced.

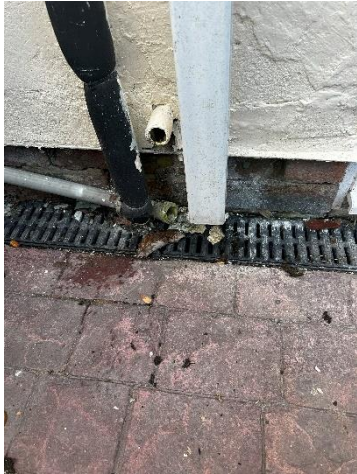
Pic25: Kitchen waste

The waste pipe from the kitchen appears to drain into an aco-drain, it could not be determined if this is connected to the main sewer and should be checked by specialist drainage company

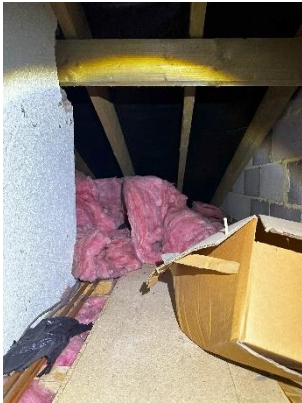
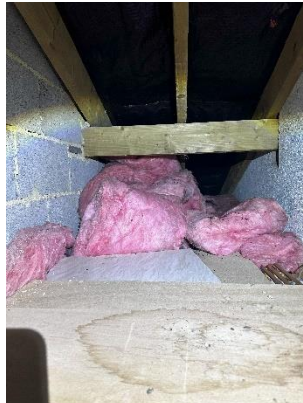
The insulation has been disturbed and requires relaying/replacing to ensure condensation and mould spores do not occur to the warm room ceiling below. The insulation depth should be at least 270mm

Pic26: displaced insulation

Pic27: displaced insulation

It is advisable to appoint a reputable roofing contractor to assess the entire roof covering (including elevations and extensions) condition, ventilation, repair costs and remaining product/material lifespan before the exchange of contracts.

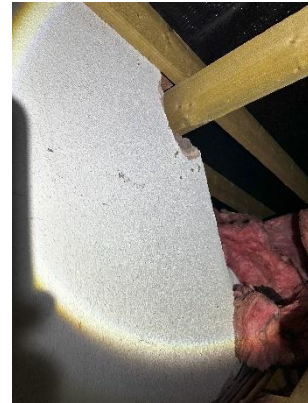
Pic28: potential lack of support to perlin

The purlin end is no longer supported on adequate masonry. There is a gap between the purlin underside to the masonry which may result in purlin and roof structure movement. The gap should be replaced with masonry, and a competent person should be consulted for remedial works guidance.

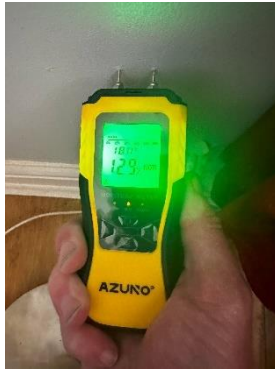
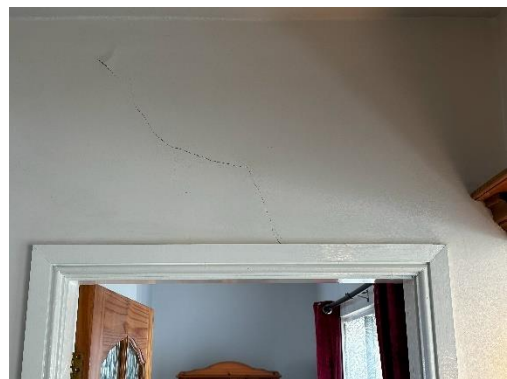
Pic31: plaster cracking

There was plaster cracking above the living room door, plaster should be removed to determine if the cracks are also present to the masonry wall. Structural cracks should be assessed by a Structural Engineer.

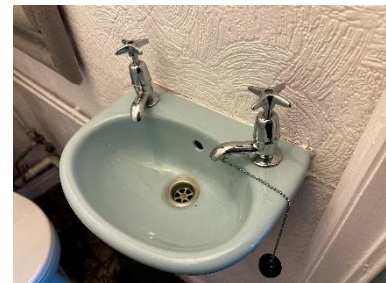
Pic42: sealed tap

The wash hand basin tap is leaking and in need of repair area causing damage. The wash hand basin tap is in the ground floor WC is fixed shut and not operational.
