LEVEL 2

# Your survey report

01/03/2025

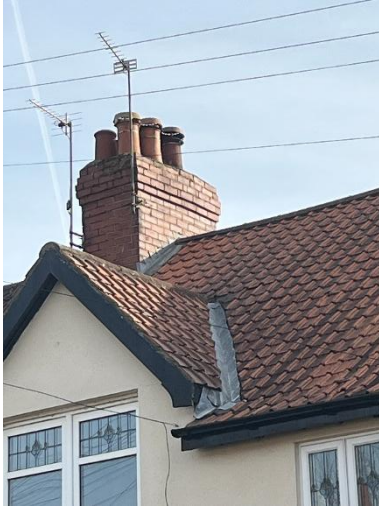
The property has a brick chimney stack. The chimney stack did not have any signs of a structural crack.

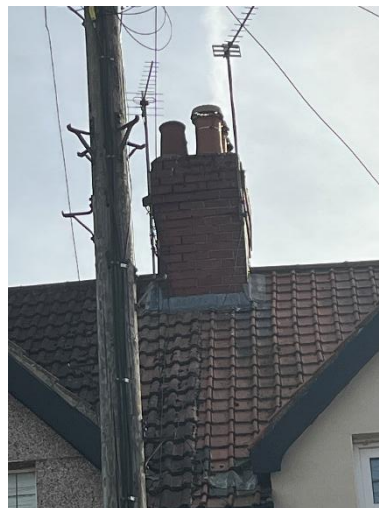
The chimney structure is leaning, this is not unusual for the age of the property. The reason for a leaning chimney stack is from expansion and eroded mortar joints. When the surface of the chimney stack is exposed to the prevailing wind, constant wetting can result in the expansion of

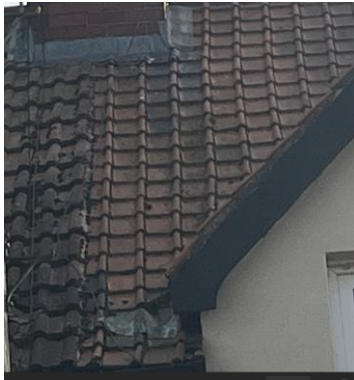
The roof covering tile is a different profile to the neighbouring property. There did not appear to be any damp or water ingress staining internally, however I would recommend the party line upstand is checked by a competent roofing contractor to ensure the installation is in accordance with the manufacturer's guidance and a watertight joint has been provided.

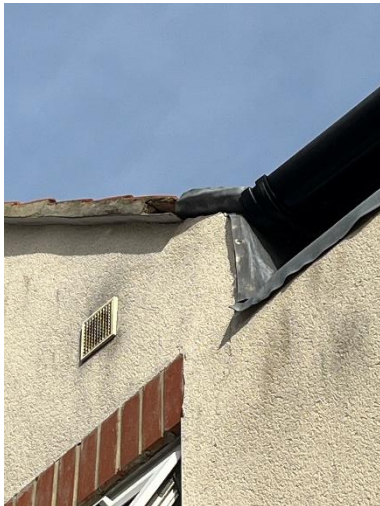
A section of verge pointing was cracked and missing to the roof line edge this is a relatively routine maintenance issue of wet roof applications. Should any damp patches appear inside the roof in the future, the mortar will need to be checked and replaced to ensure the structure is watertight and that the roof pitch tiles cannot be lifted in severe weather.

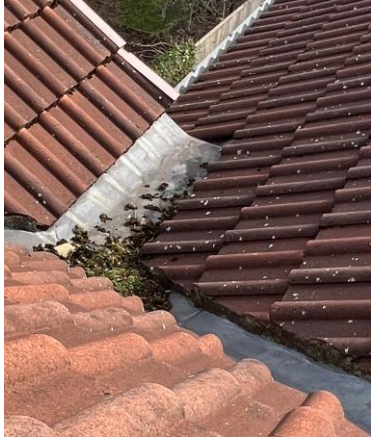
Moss and algae are beginning to form in the valleys, this is a relatively maintenance issue. However, the roof pitch will need to be cleaned in the future with a suitable moss and algae treatment. Moss can hold water, and when frozen can damage the surface of the roof pitch covering over time. Moss can also reduce ventilation which can increase condensation within the roof space.

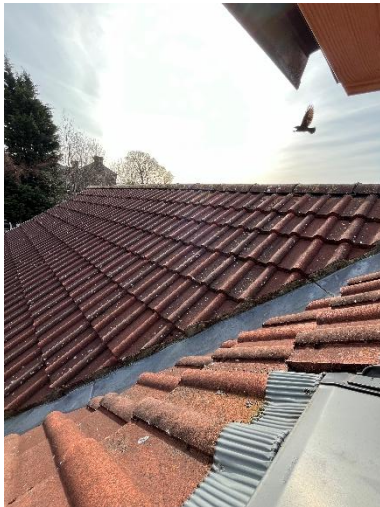
The valley pointing was cracked and missing to the valley roof tile edge line, this is a relatively routine maintenance issue of wet roof applications. Should any damp patches appear inside the roof in the future, then the mortar will need to be checked and replaced to ensure the roof is watertight.

It is advisable to appoint a reputable roofing contractor that is registered with the National Federation of Roofing Contractors or an approved governing body to assess the entire roof covering (including elevations and extensions) condition, ventilation, repair costs and remaining product/material lifespan before the exchange of contracts.

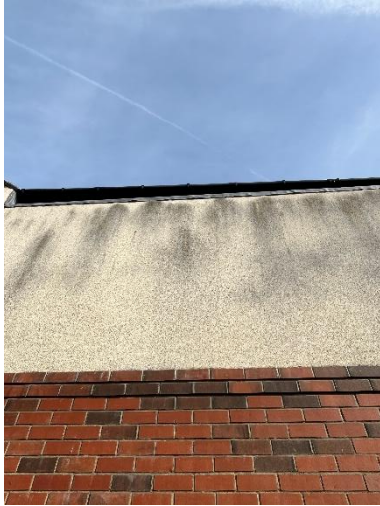
The render below the gutter joint is water stained. The gutter joints should be checked as masonry saturation can damage the mortar pointing, masonry face and can lead to internal damp.

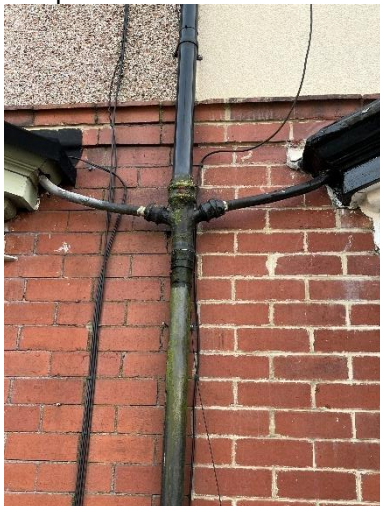
The rainwater downspout joint has a vegetation build up on the joint line which can indicate a defective seal, which is a relatively common maintenance issue. A leaking rainwater downspout over time can saturate/damage the masonry face during cold weather. The vegetation should be

removed when next maintaining the outside of the property, and checks should be then made during inclement weather to ensure the joint lines are watertight.

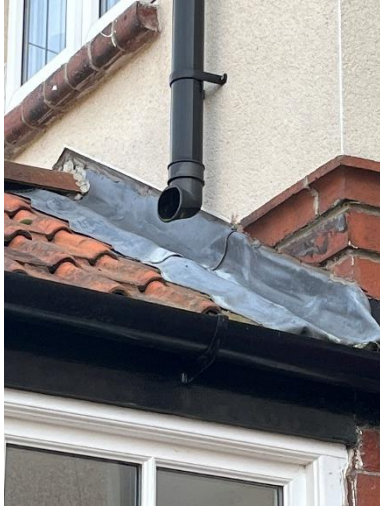
The downspout shoe is installed at a height that will not allow rainwater to expel onto the below roof line as required, an incorrectly fitted shoe can cause rainwater to overshoot the gutter leading to the saturation of masonry below.

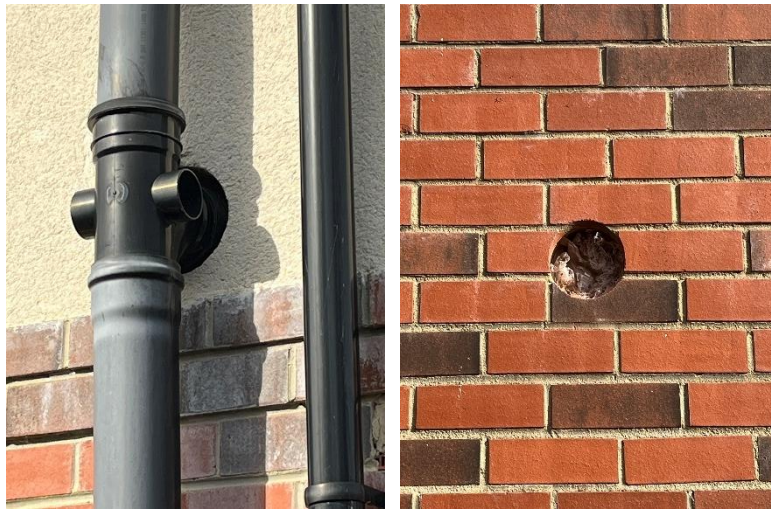
The mortar was missing to the circumference of the soil branch pipe. The mortar will need to be replaced to prevent water ingress and a cold path forming internally which could lead to condensation and mould on plasterwork.

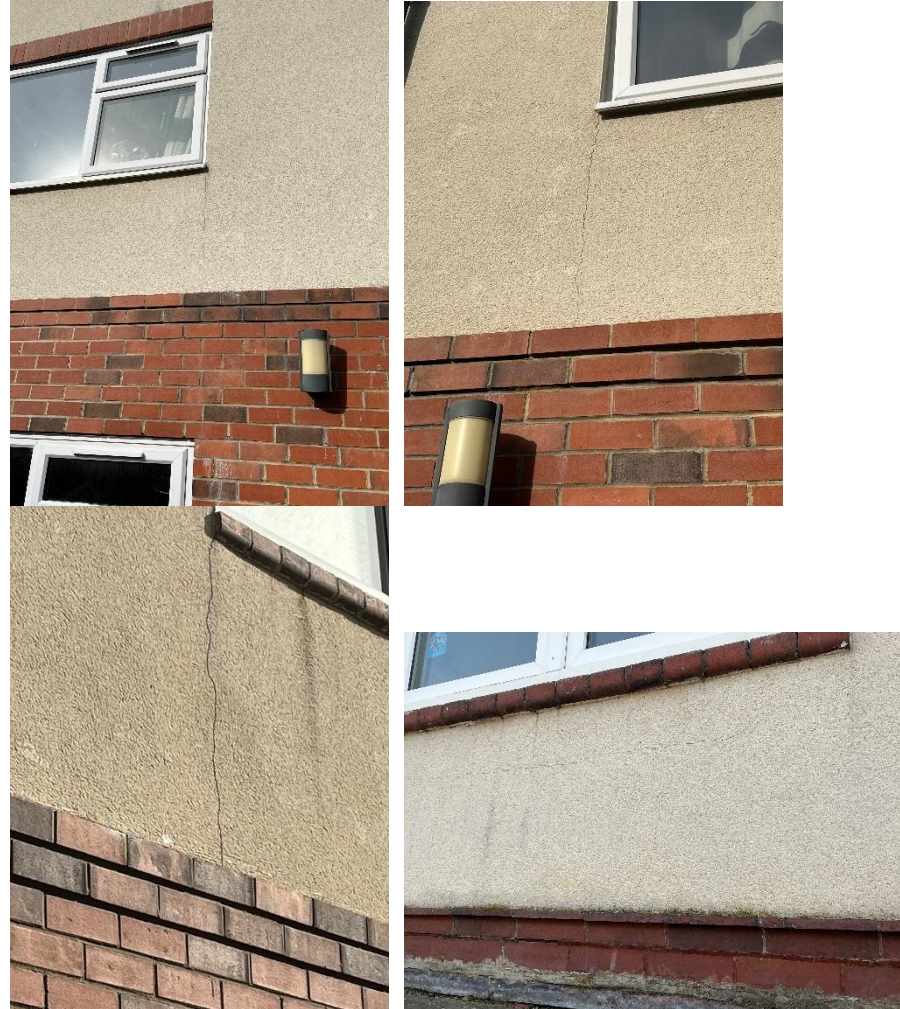
The render finish coat has minor cracking to several areas. This cracking may allow water to seep behind the coating which can further loosen or crack the render during inclement weather. The cracked render coating should be surface repaired or removed and then prepared to receive new render. The repair should be carried out by a suitably experienced and qualified person.

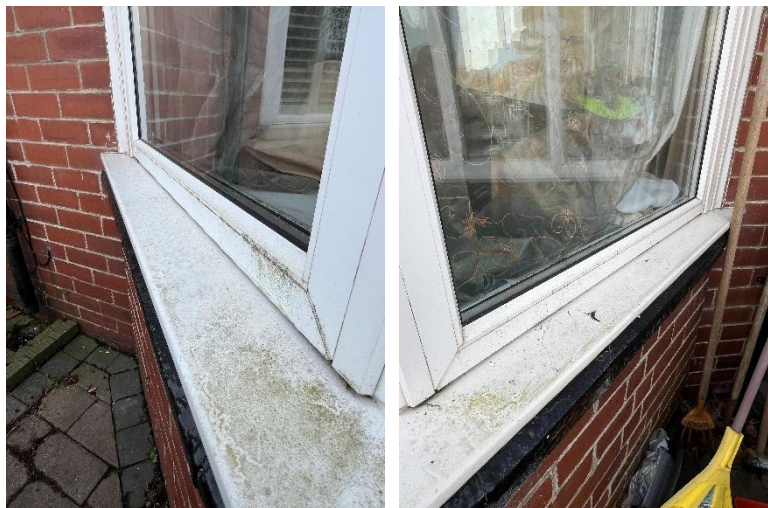
The window frame has external glazing beading which is no longer used in a modern window design. The external beading and double-glazed units can be removed externally. It is advisable to make enquires with the proposed property insurance company, as external glazed beading may be an exclusion from an insurance policy. I would recommend replacing the window frames for property security.

There are areas of moss and algae forming to the junctions of the Upvc frame and glass. Moss can hold water and can deteriorate the Upvc frame gasket and seals and the glazing unit seals. The Upvc frame will need to be cleaned with a suitable moss and algae treatment.

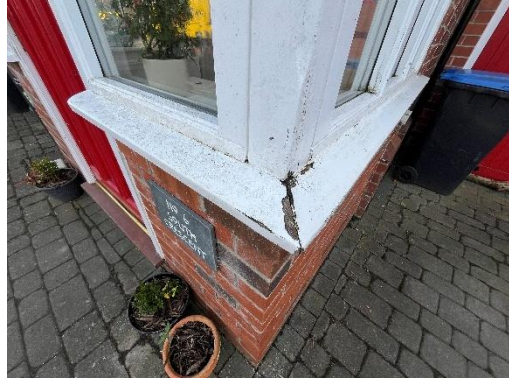
The paintwork to the window has peeled and blistered. The timber requires examining for timber decay and rot and treating/replacement if required. The timber should then be prepared for a new primer, base, and topcoat paint application. It is recommended the external decoration is recoated on a five-to-seven-year cycle.

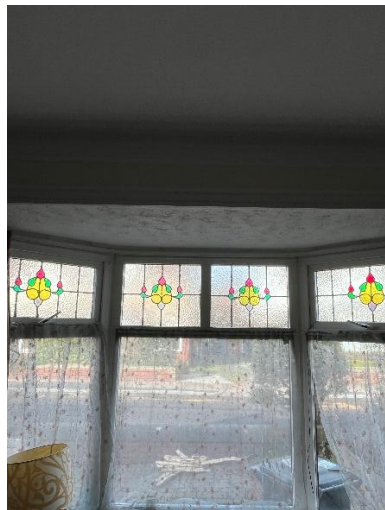
The top openers have dropped and require adjustment as the opener is catching the frame. Openers that do not close into the frame rebate correctly can damage the opener hinge, double glazed unit, and the window frame.

It is recommended to seek advice from a suitably qualified and experienced 'competent person scheme', such as a FENSA window and door installation company to assess the window condition and remaining service life of the windows against repair works.

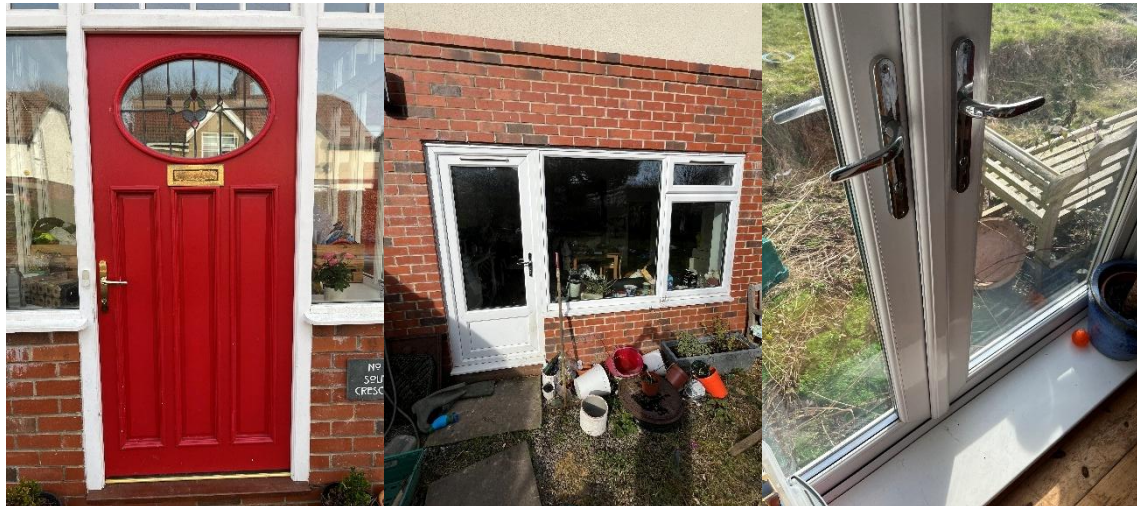
It is advisable to install a door deflector to the bottom rail of the door. A deflector projects rainwater away from the threshold, which helps to reduce the door casing ends from becoming saturated and leading to timber decay.

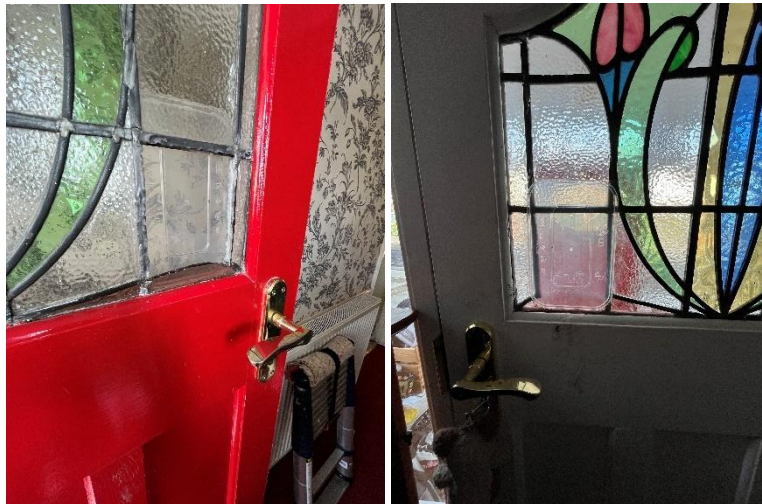
Glazed panel to the front door is damaged/smashed and requires replacing to maintain security requirements.

It is recommended to seek advice from a suitably qualified and experienced 'competent person scheme', such as a FENSA window and door installation company to assess the window condition and remaining service life of the windows against repair works

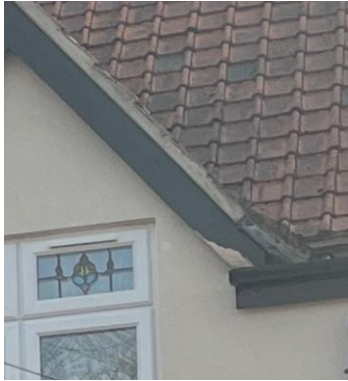
The paintwork to the fascia board have peeled and blistered. The timber requires examining for timber decay and rot and treating/replacement if required. The timber should then be prepared for a new primer, base, and topcoat paint application. It is recommended the external decoration is recoated on a five-to-seven-year cycle. Repairing roofline timbers requires scaffold access equipment (which can be costly). I would recommend obtaining estimates of works from competent contractors before the exchange of contracts.

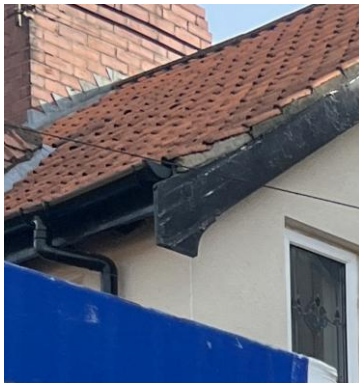
There are sections of the barge board that are decayed and rotten, the extent of which is unknown. Sections of timber rot can be removed and spliced with new timbers, or the length section replaced. Repairing roofline timbers requires scaffold access equipment (which can be costly). I would recommend obtaining estimates of works from competent contractors before the exchange of contracts.

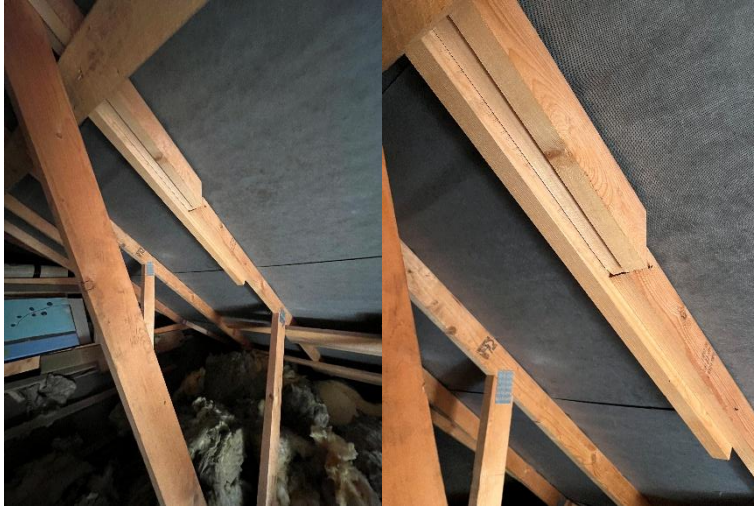
The truss has been cut. Roof trusses should not be cut or altered in any way. A roof truss manufacturer or a Structural Engineer should assess the alteration.

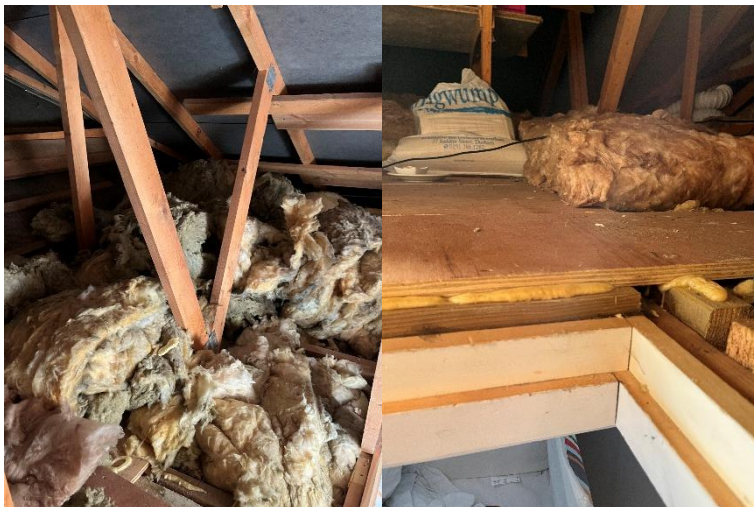
The insulation has been disturbed and requires relaying/replacing to ensure condensation and mould spores do not occur to the warm room ceiling below. The insulation depth should be at least 270mm.

The loft is boarded with a floor decking, the space between the plastered ceiling and decking board is less than 270mm. This means the insulation will not meet the recommended depth standards for keeping the ceiling adequately insulated. Squashed insulation can lose up to 50% thermal efficiency as the insulation works by trapping warm air inside. Should the decking boarding become wet to the underside then a ventilation gap should be introduced between the insulation and boarding decking. Should cracking or deflection occur to the ceiling below then bracing should be introduced to strengthen the ceiling span.

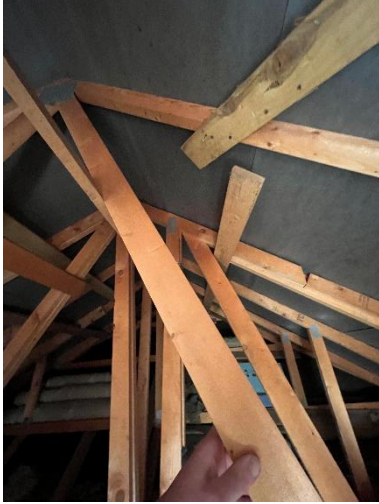
Elements of the diagonal bracing may have also been missed from the construction. The timber bracing provides rigidity to the truss roof structure. A competent person (Truss manufacturer) will be able to determine if an additional timber bracing should be installed.

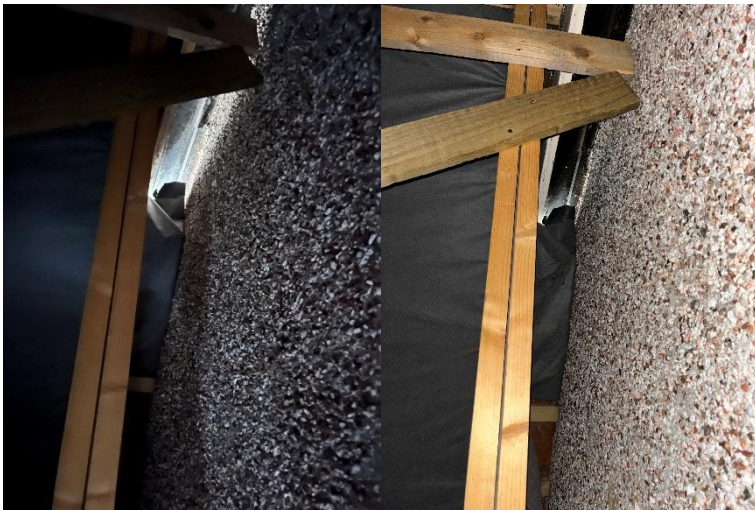
The original gable wall continues between the house and extension, voids are evident at this junction and should be remediated to event insect and moisture ingress

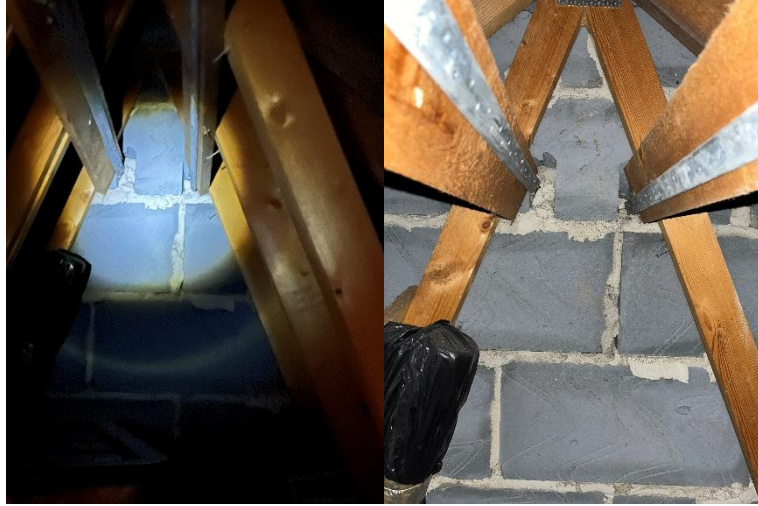
The lateral restraint straps did not appear to have adequate fixings. The fixings help to ensure the strap is fixed rigid against the timber bracing. Timber bracing and straps ensures the roof structure and gable masonry are restrained/tied together which provides an additional masonry restraint. It is advisable to appoint a competent person to provide the additional fixings. The straps are not returned onto a solid masonry unit and would appear that the roof is restrained by loose mortar

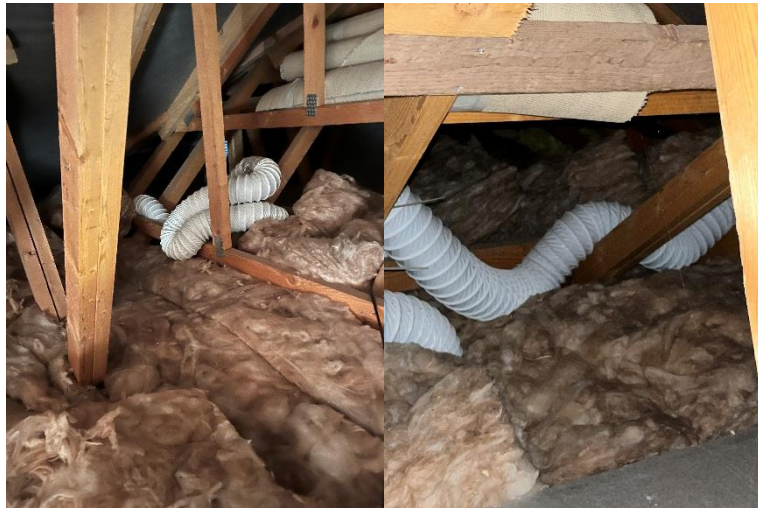
The extractor ducting within the roof space is incorrectly laid which will reduce the unit extraction flow rate. The ducting should be altered to ensure a vertical/horizontal line from the unit to the roof discharge point.

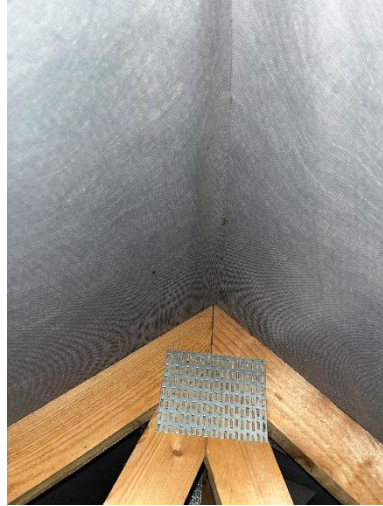
There was no ridge ventilation to the new roof structure. The felt should be sliced to allow ventilation at the ridge through the dry ridge systems. In severe cases of inadequate roof ventilation, excessive condensation can form leading to timber decay and rot to the roof timber structure. A qualified and suitably experienced person should be appointed to advise on ventilation requirements.

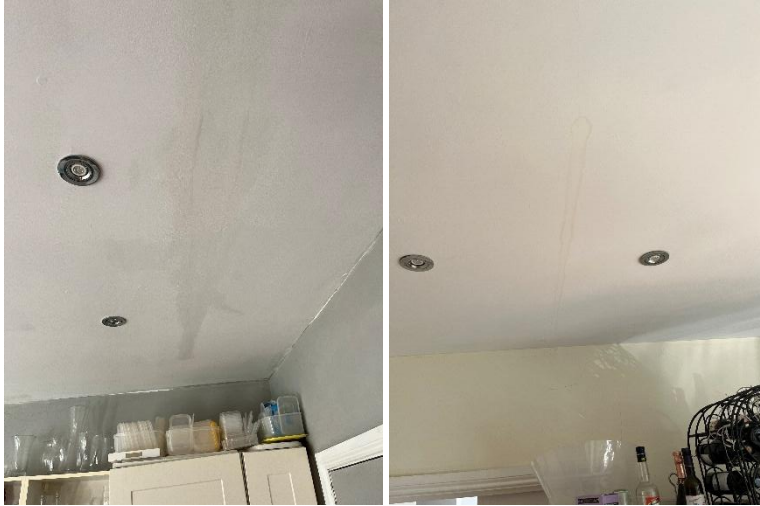
There is water staining to the kitchen ceiling. The water staining should be investigated to ensure there is no water leakage above the ceiling. The ceiling may also need a water stain block repair and redecoration.

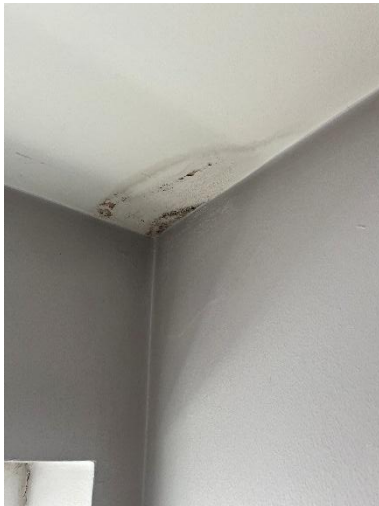
Mould and water staining are visible to the bathroom ceiling, which is adjacent to the hidden box guttering. The guttering will need investigating to check the gutter line and install. The ceiling may also need a water stain block repair and redecoration.

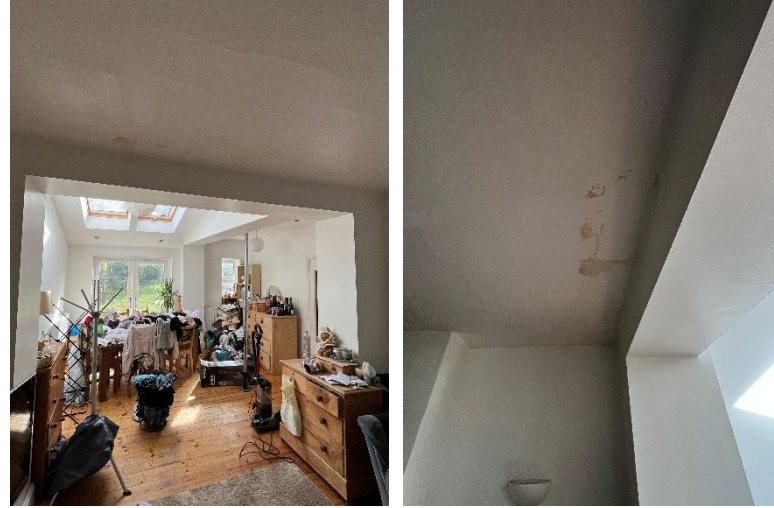
Staining and damage is visible where the extension meets the existing house rear elevation a common defect when an extension abuts an existing structure and no horizontal cavity trays have been installed at the roof abutment.

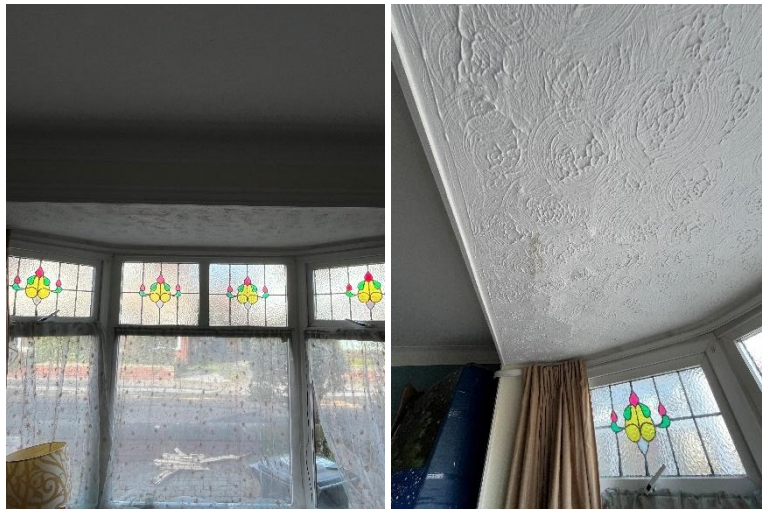
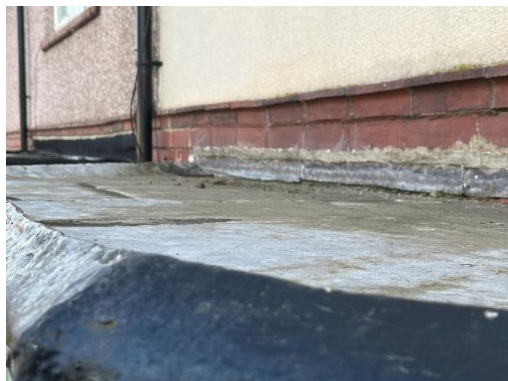
The ceiling below the bay roof is water stained and damaged, the lead upstand is damaged and not installed in a way to prevent the ingress of moisture. The bay roof appears to have reached the end of its lifespan, this should be investigated by a competent roofing contractor and where required replaced.

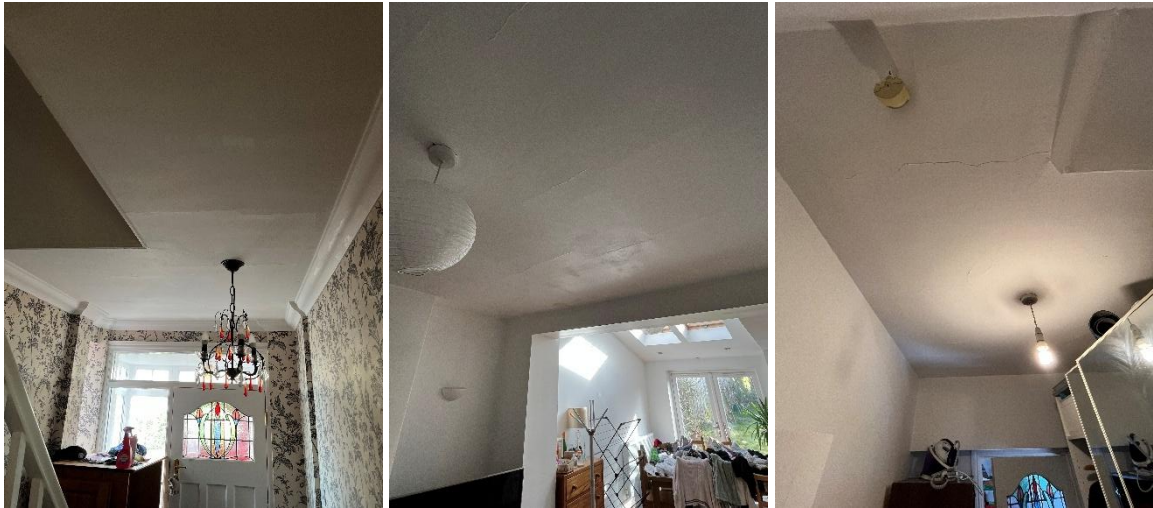
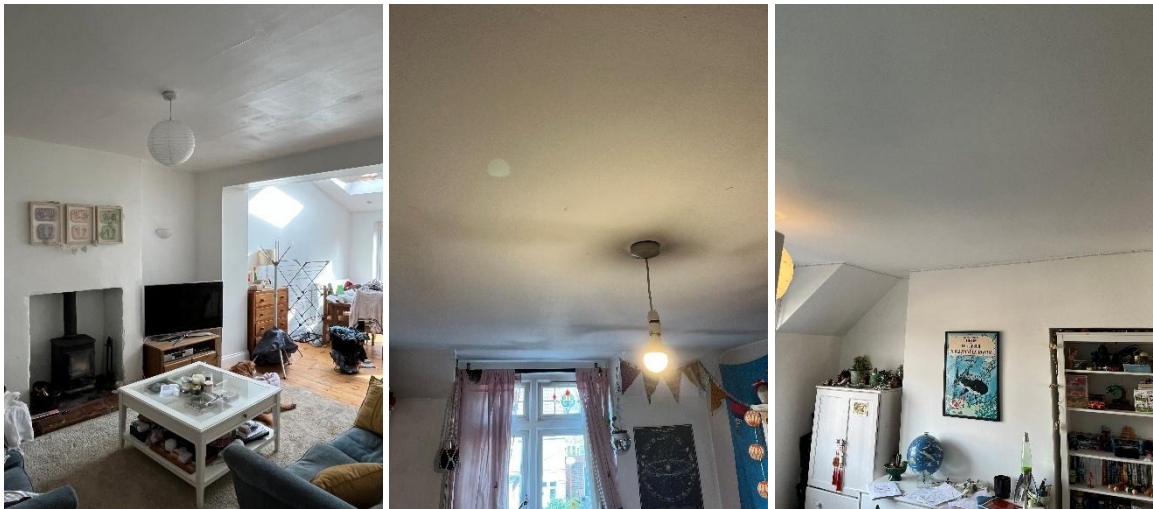
There were some lines, minor cracks, and indentations to the ceiling. The indentations may be filled, sanded back and painted over. This may be a reoccurring repair.

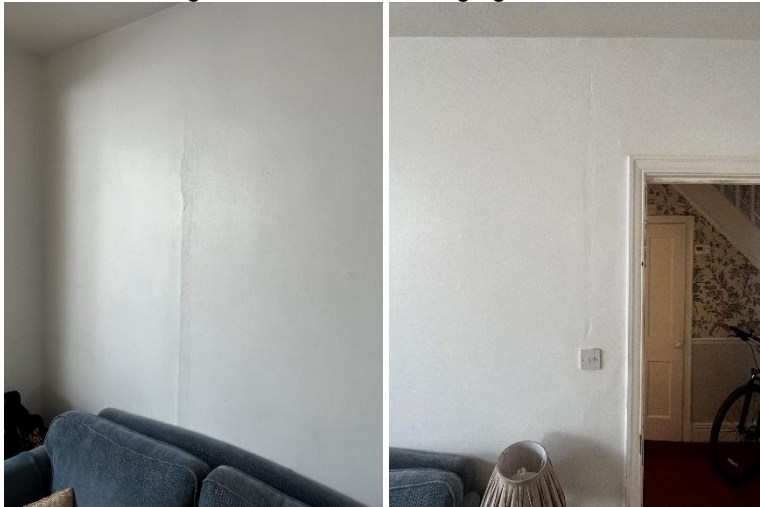
There were some lines and indentations to the plaster finish. The indentations may be able to be sanded back, filled, and painted over.

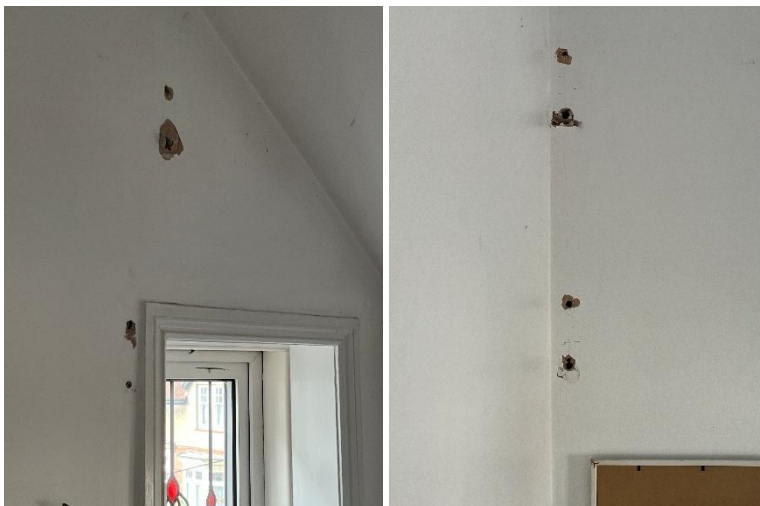
There were several holes to the plaster and partition walls. The holes may be filled with a back board and filled and sanded over.

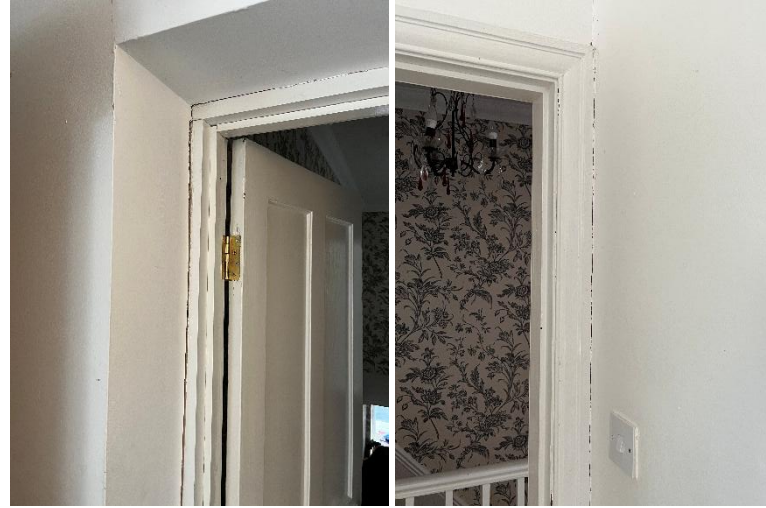
An opening had been formed and altered within the property. Checks should be made to ensure the alteration has been authorised by building control.

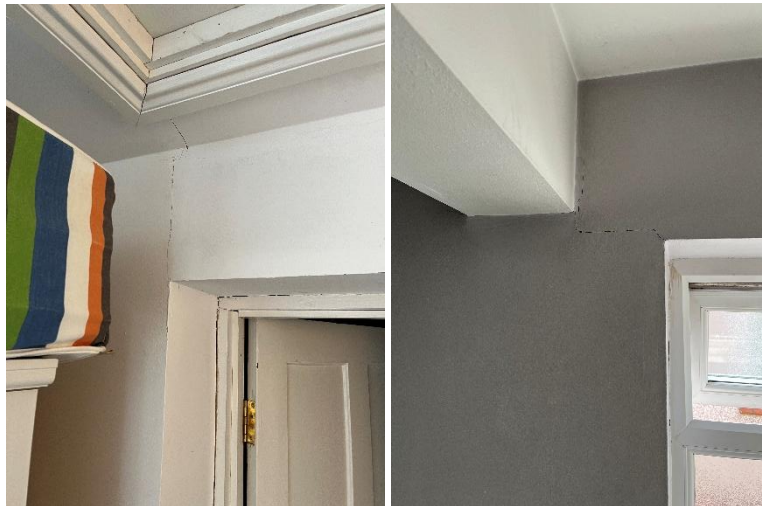
There was plaster cracking to the main bedroom and bathroom walls. The plaster work has also de-bonded from the masonry wall. The plaster should be removed to determine if the cracks are also present to the masonry wall. Structural cracks should be assessed by a Structural Engineer.

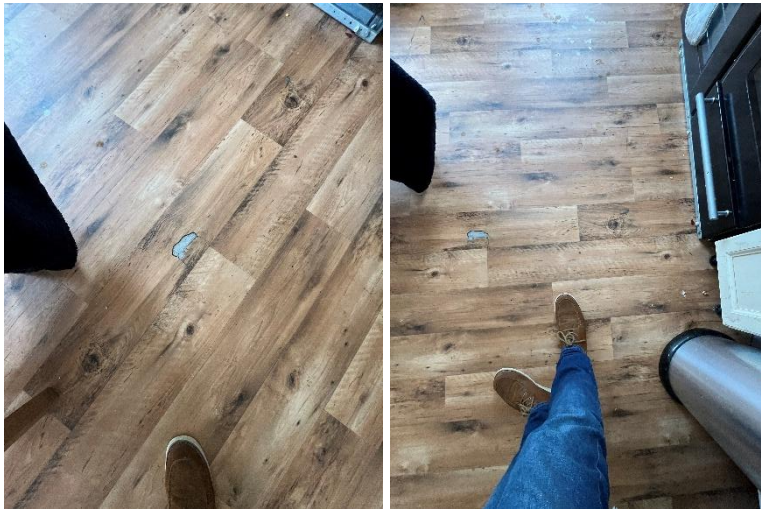
The kitchen floor covering is damaged, it appears the floor covering has been installed incorrectly and without a suitable base. There are also indentations in the floor that should be level to prevent a trip hazard and damage to the floor covering.

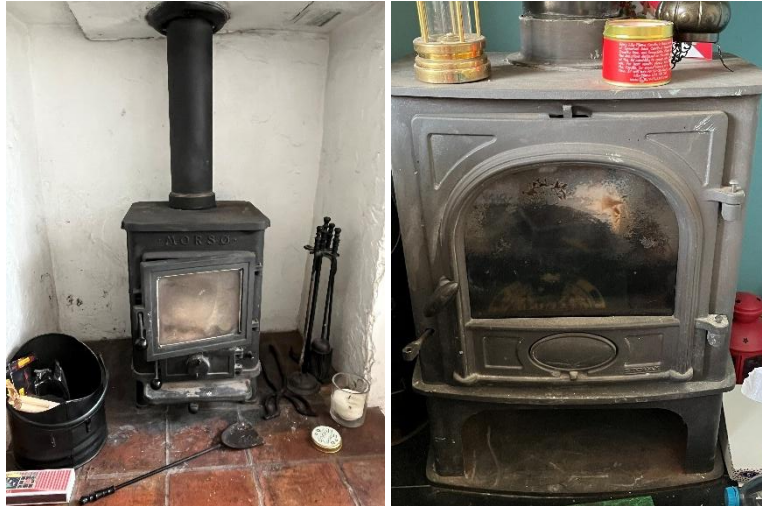
It is unknown if the chimney has been swept and the appliance serviced. If not, both should be checked by a Heating Equipment and Testing Approval Scheme (HETAS) Approved servicing engineer and/or chimney sweep. Your Legal Advisers should make enquires on annual inspection/service records.

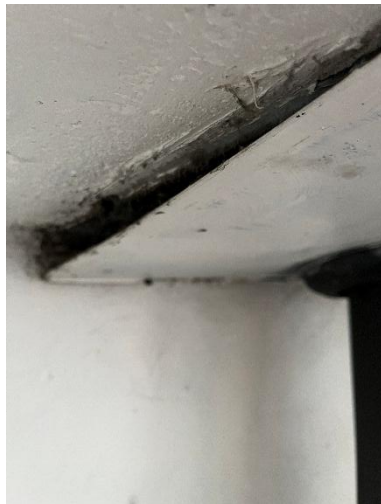
Rear living room stove fireplace is insecure and could result in the failure of the suitable operations of this stove.

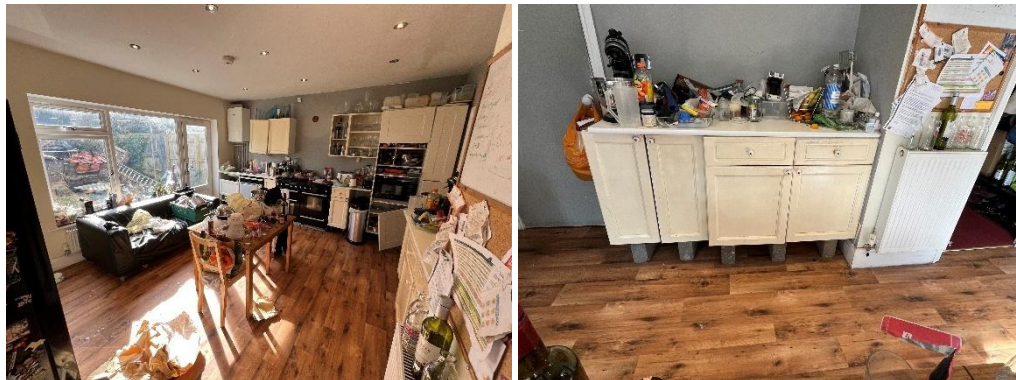
The kitchen needs to be removed and replaced, the current units are temporary insecure, and failure is evident to all units.

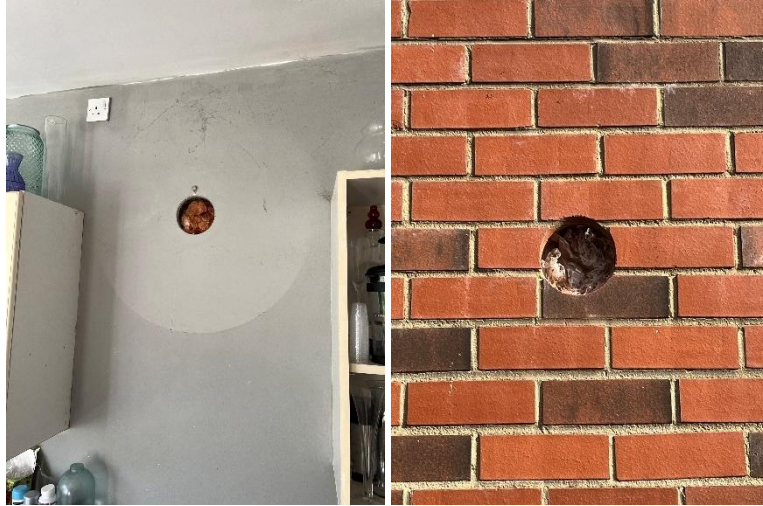
There is no extractor unit to the kitchen. The extractor should be installed to ensure cooking odours and moisture within the kitchen is extracted externally. Moisture laden air created condensation and Mold spore when in contact with cold surfaces such as window reveals.

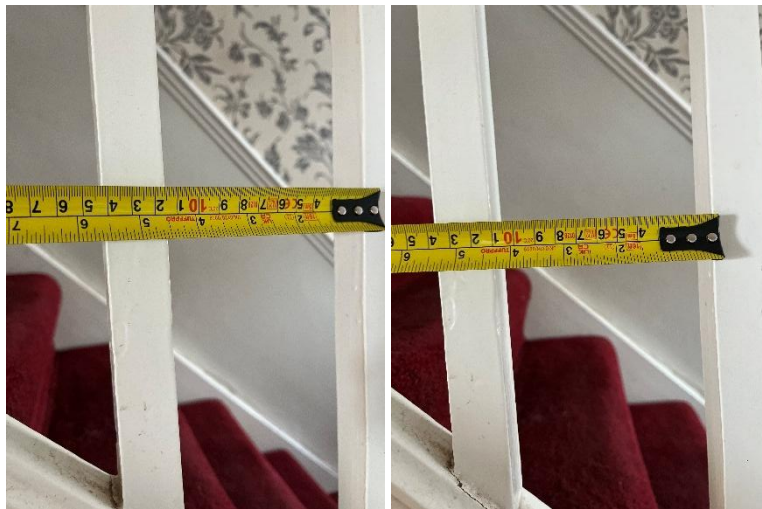
The existing period balustrade and handrail are not to the current building regulation and may pose as a health and safety risk due to a large gap between spindles. The current gap between spindles is a maximum of 115mm.

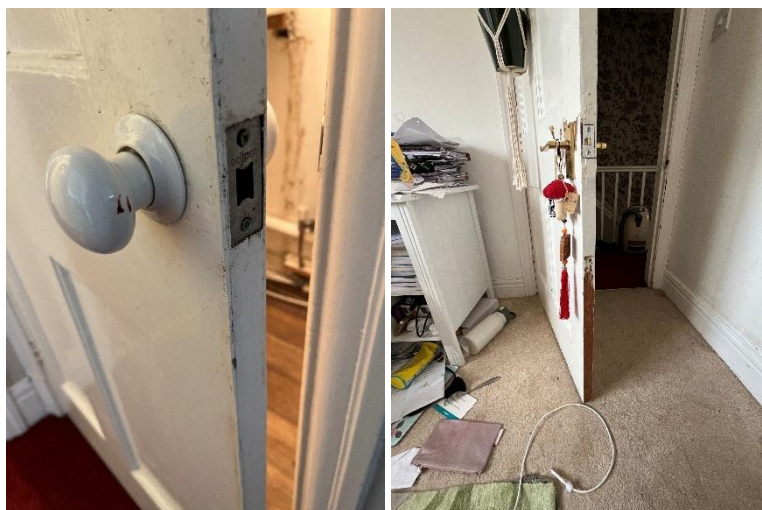
The latch mechanism has also failed in several doors. All doors within the property should be

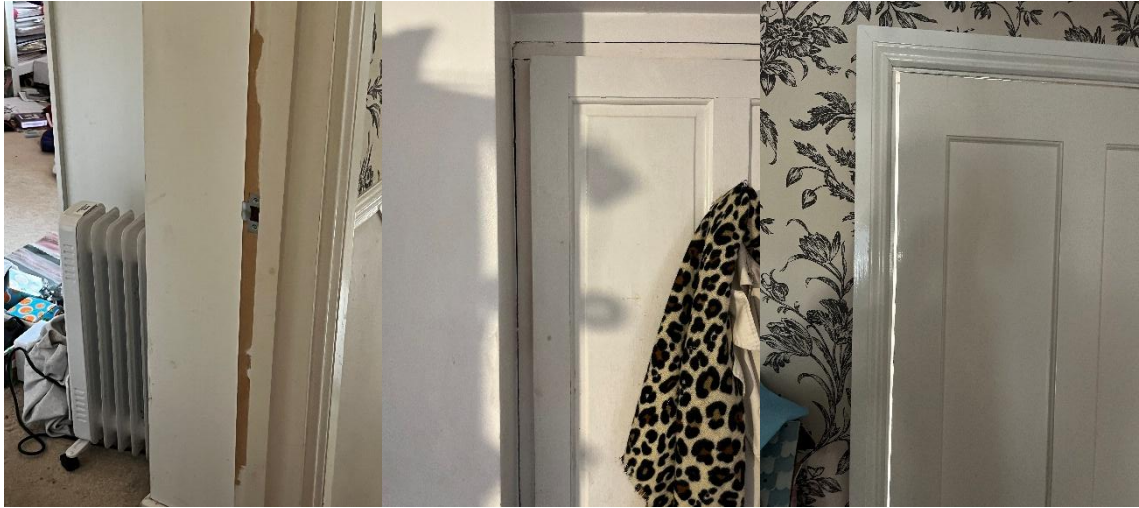
There are period doors within the property that do not close correctly into the door casing. Internal doors that close correctly may slow the passage of fire smoke. It may be a consideration to refit the doors or replace them.

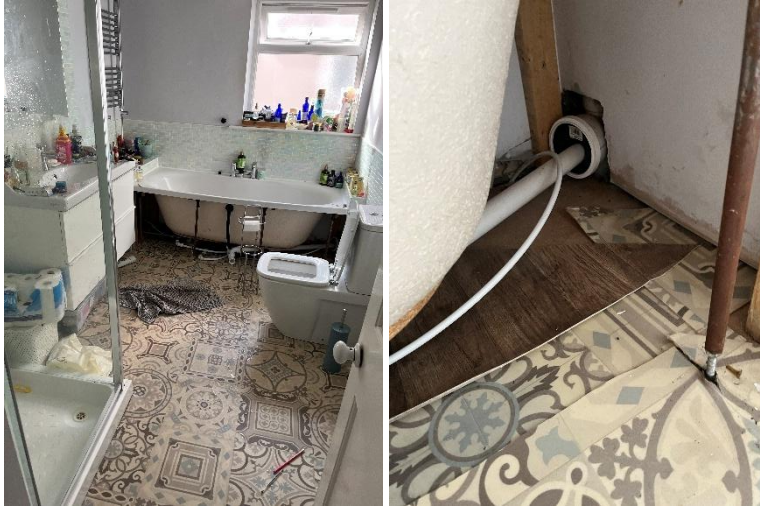
The bath installation is incomplete, and it appears drainage connections are unsuitable, this should be checked by a suitably competent person to prevent further damage.

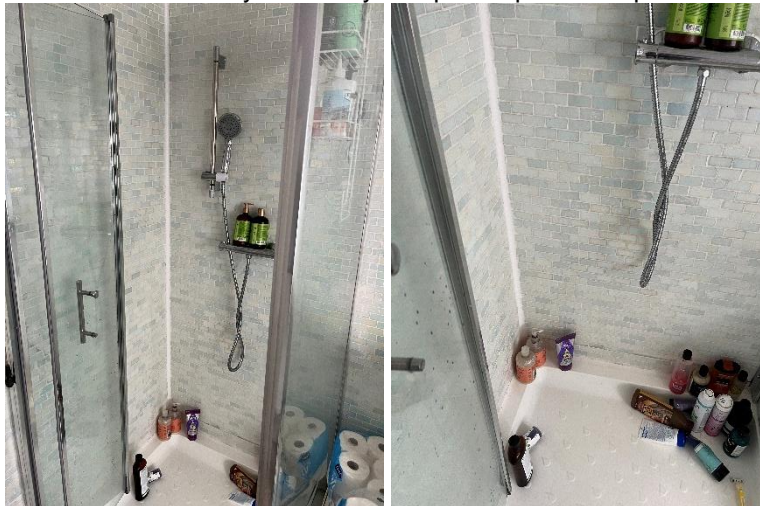
The shower head and bathroom fittings were not tested during the inspection. The shower head should be suitably cleaned, and hot water should be run through the system to ensure bacteria such as legionella is not present.

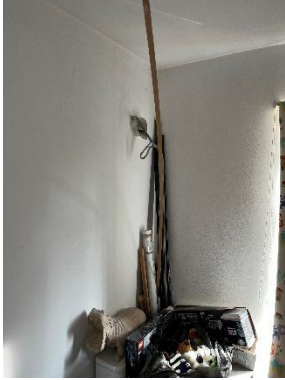
The ensuite bathroom is not installed, and this should be considered when budgeting for the remedial works required to this property, works to the ensuite will include all plumbing, electrical and decorative works.

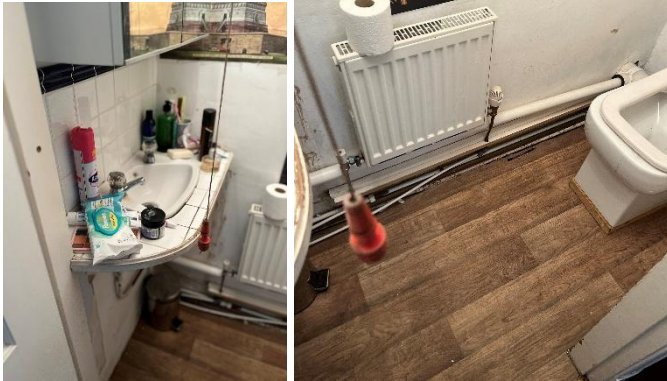
The ground floor WC requires remedial works, the whb is insecure and will need removing and reinstalling with suitable fixings, pipework is exposed and should be suitably encased to prevent damage.

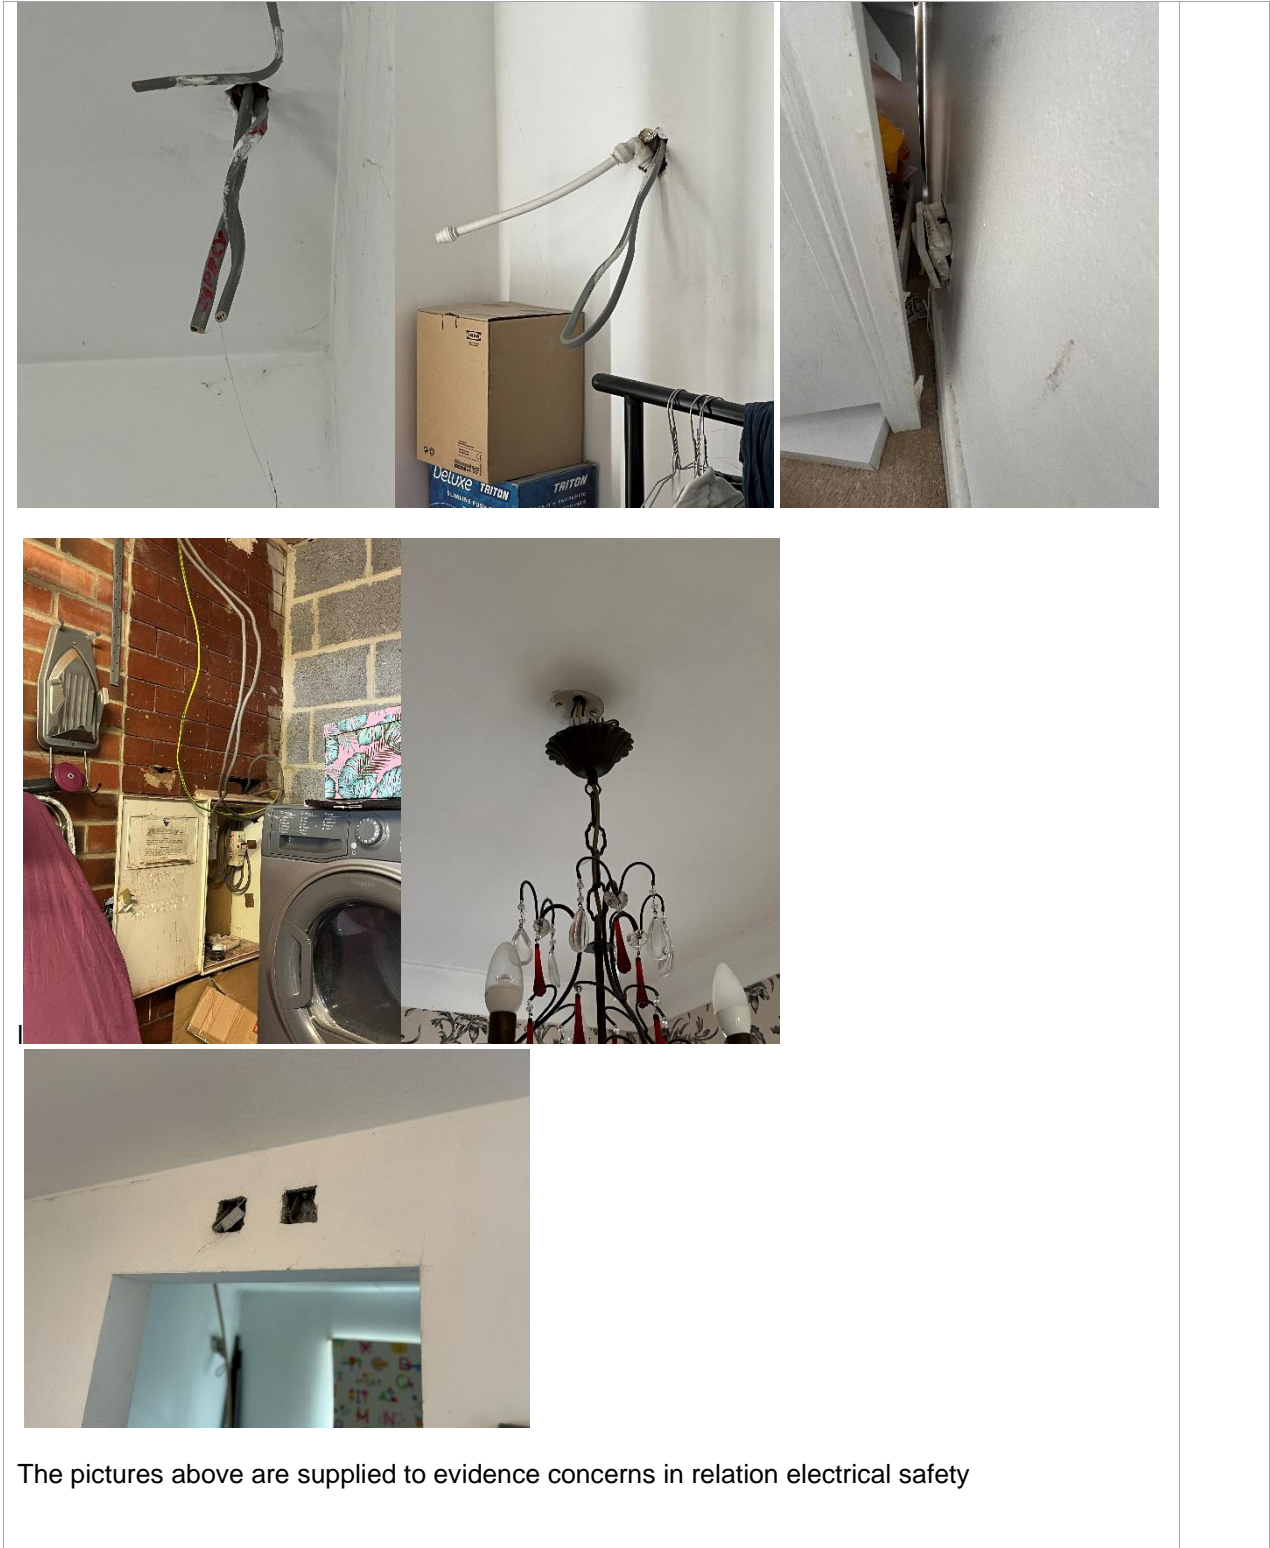
The pictures above are supplied to evidence concerns in relation electrical safety

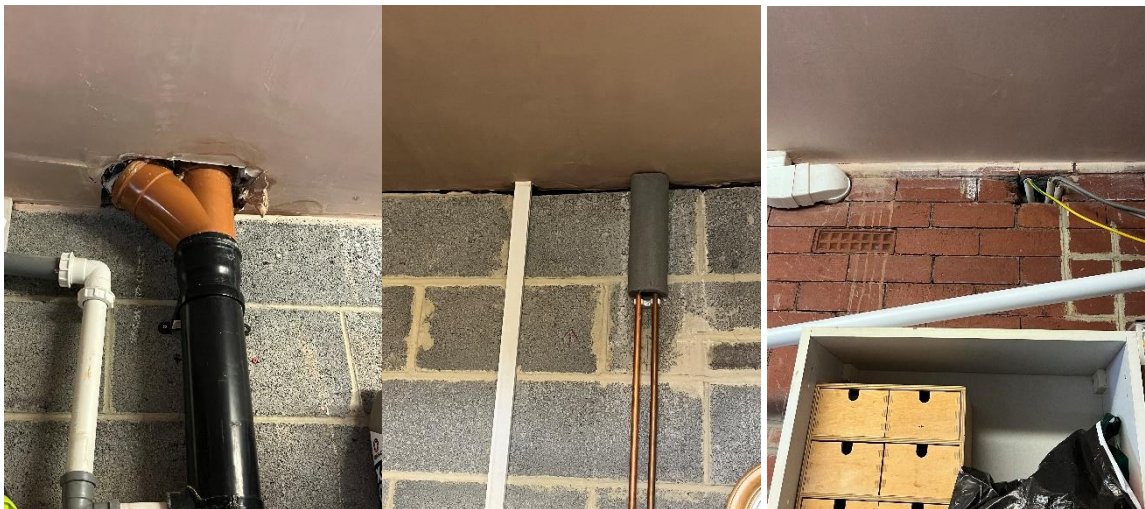
Fire compartmentation has not been maintained through penetrations, where pipes of more than 40mm pass through a fire compartment a suitable fire collar should be installed to maintain its integrity, where smaller penetrations are made then these should be filled with a fire intumescent mastic.

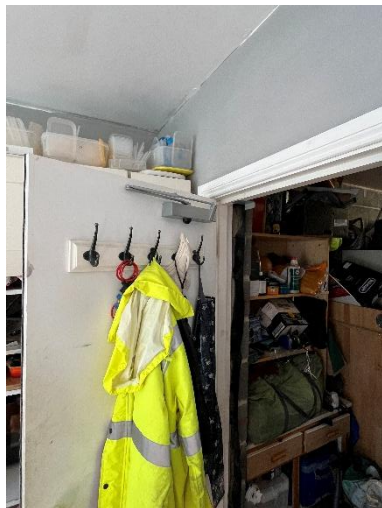
The garage door is a fire door. The self-closing mechanism is damaged and does not operate as required, the cold smoke seal housed within the door stile must touch the door casing leg to be effective in preventing smoke from entering the property. The cold smoke seal should be changed to ensure the bristles touch the casing leg.

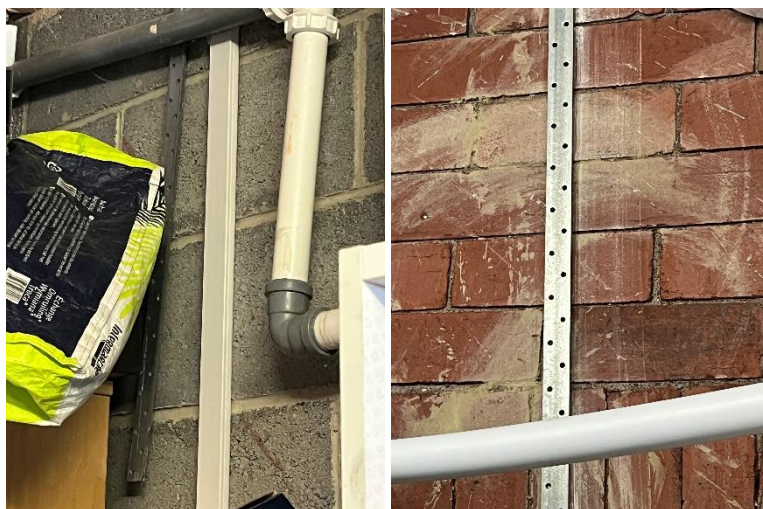
The metal wall plate straps have not been fixed to the masonry during the property construction. The wall plate straps function, is to provide an anchor against roof structure uplift or movement. It is advisable to provide fixings as per the wall plate manufacturers guidance.
