LEVEL 2

Your survey report

Property address

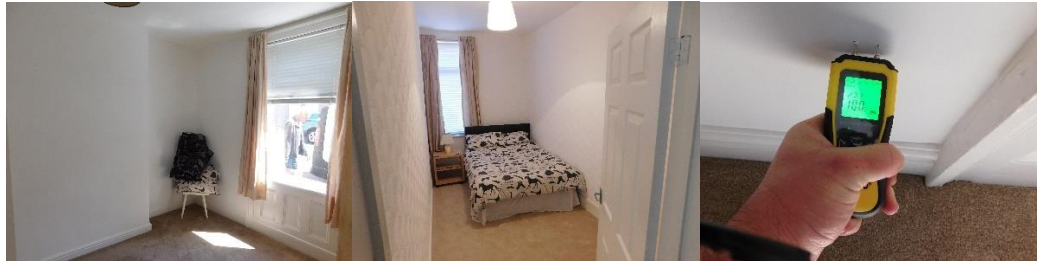
A damp reading was undertaken to the ground floor walls which showed a consistent, acceptable moisture reading level of 10 percent

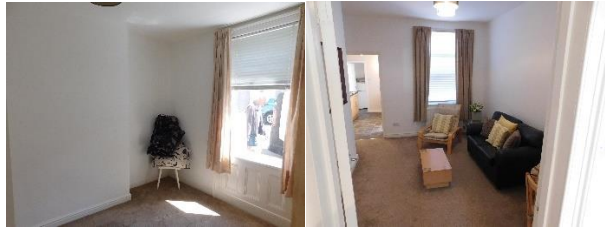
The property includes a chimney breast to the main bedroom and living room. Appliances have been removed with the opening blocked up. No signs of consideration or ventilation was observed, and a specialist should be instructed to establish the requirement. Lack of ventilation to a close space could eventually lead to damp issues.

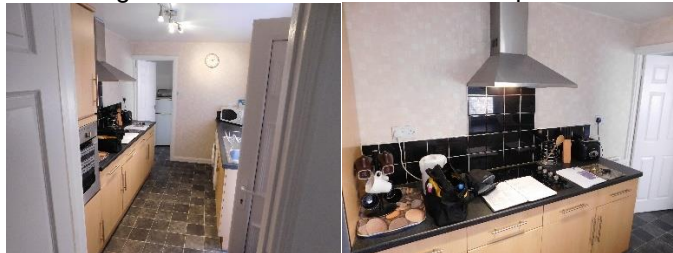
E6 Built-in fittings (built-in kitchen and other fittings, not including appliances)

The units are made from MDF or chipboard, worktops are made from high density chipboard and coated with a plastic laminate. Units and worktops must remain relatively dry, or the material will soak any excess moisture/water and swell. Small indentations or delaminated worktop joints can be repaired by a surface medic. Worktop joints and the sink drainer cut out are particularly prone to swelling which will also cause the worktop to delaminate.

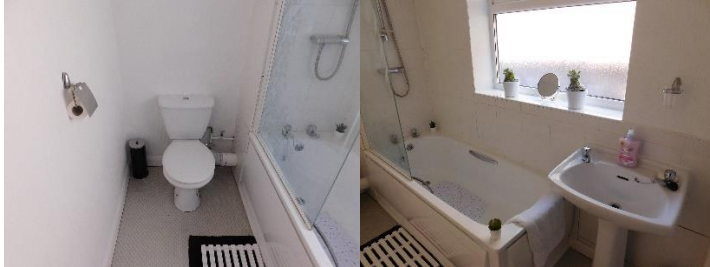
The shower head and bathroom fittings were not tested during the inspection. The shower head should be suitably cleaned, and hot water should be run through the system to ensure bacteria such as legionella is not present.

The extractor unit operated when turned in the on position. We cannot determine how efficient the extractor is at removing moisture laden air. An extractor that is not operating correctly can allow excess moisture to build up within the air and circulate around the property structure. Once the warm moisture laden air, meets a cold surface, saturation of surface capillaries can occur leading to mould spores. Should the extractor not operate correctly when in use, a suitably qualified and experienced person should be appointed to provide and install a suitable extractor.

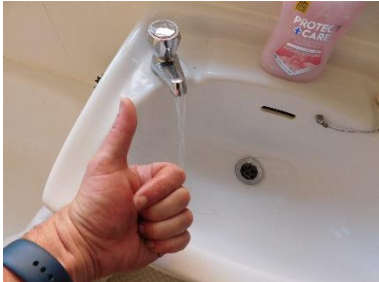
F5 Water heating

<p>Hot water is provided direct by the boiler.</p> <p>At the time of the survey the hot water tap was checked in the bathroom and hot water was provided.</p>
