# Your survey report

Property address: [REDACTED]

Inspection date 17/10/2024

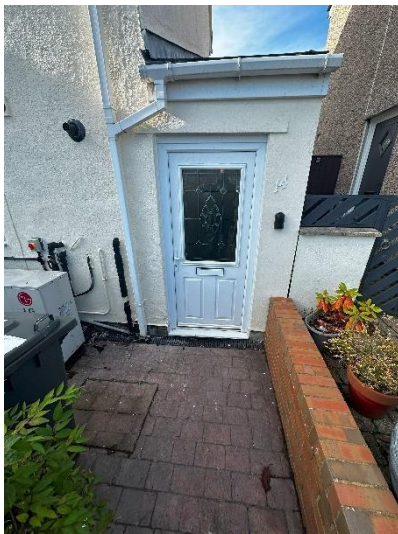
Pic 4: Block paved path

The property has a small garden area to the front with shrubs bordering the footpath. Access to the property is via a block paving path boarded by a small masonry wall on the party line.

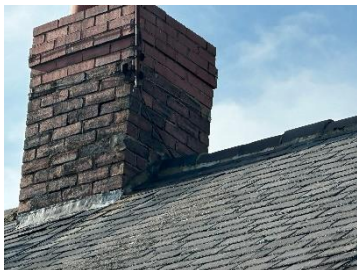
Pic 5: Chimney front elevation

It appears from the ground level that the saddle flashing is missing. Lead work to a chimney stack structure protects the masonry from becoming saturated and forms a watertight junction between the roof covering and chimney stack structure.

It is advisable to appoint an approved and reputable roofing contractor to assess the entire chimney stack to provide repair costs, and to provide additional recommendation to any masonry repairs.

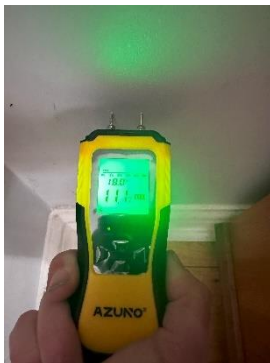
Pic29 & 30 example moisture readings

Where damp readings were achieved to the ground floor walls which showed a consistent, acceptable moisture reading level below 16 percent.

It is advisable to appoint a specialist timber and damp contractor that is registered with the property care association or an approved governing body to undertake an intrusive survey. The contractor will determine the extent of damp repair work and will provide repair costs. The damp specialist should check all internal and external perimeter walls to the ground floor. The ground floor construction material should also be checked for damp issues.

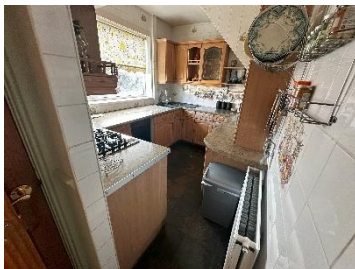
Pic35: Kitchen

Several draw fronts require realignment as this can cause the front of the unit to snap away from the draw shelf unit during use

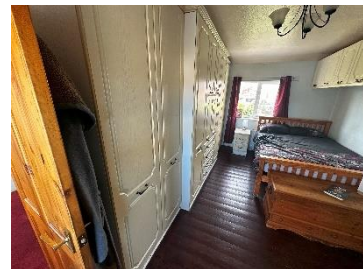
Pic37: Wardrobes

The built-in wardrobes are basic in design but functional. Minor repairs such as hinge realignment and securing of handles are required periodically with all built in wardrobes.

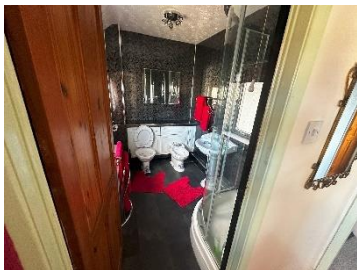
Pic40: bathroom

The shower enclosure is showing signs of wear and tear and may be defective. The shower enclosure may need to be replaced to prevent water damage to the bathroom floor.

The wash hand basin tap is leaking and in need of repair area causing damage. The wash hand basin tap is in the ground floor WC is fixed shut and not operational.
