LEVEL 2

# Your survey report

01/03/2025

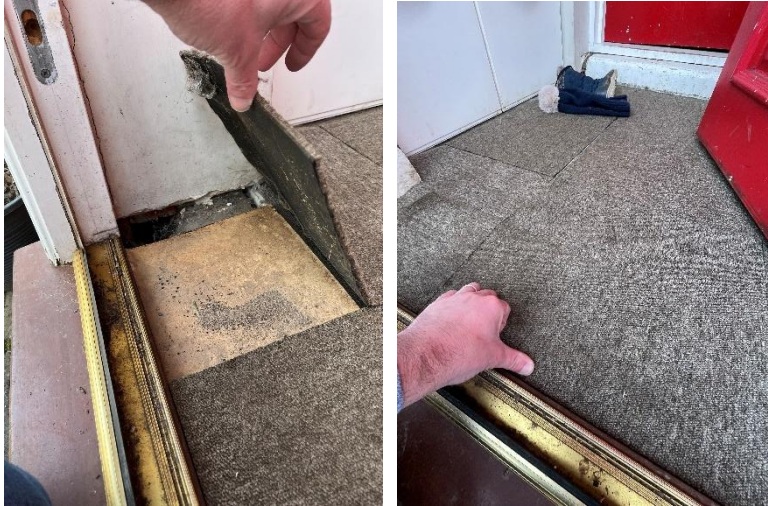
2

The porch floor design has been incorrectly constructed leaving an open cavity at the door threshold which is unstable under foot.

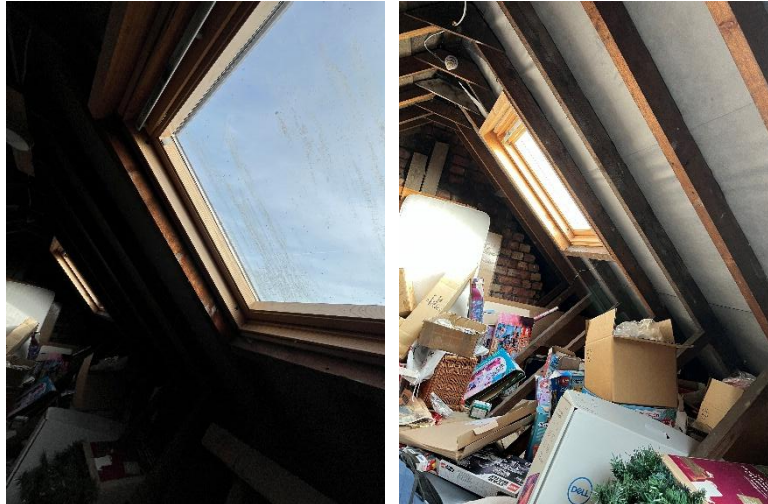
2

Velux windows have been installed to the rear elevation and the structural design should be checked; the existing roof structure does not appear to be correctly trimmed to take the additional loadings.

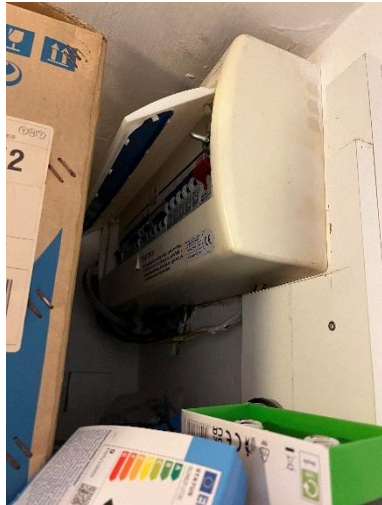
The consumer unit was located at high level within the hallway/cloakroom

3

There were several socket fronts not screwed to the back box. The cover plates should be screwed back to prevent the risk of electrocution.

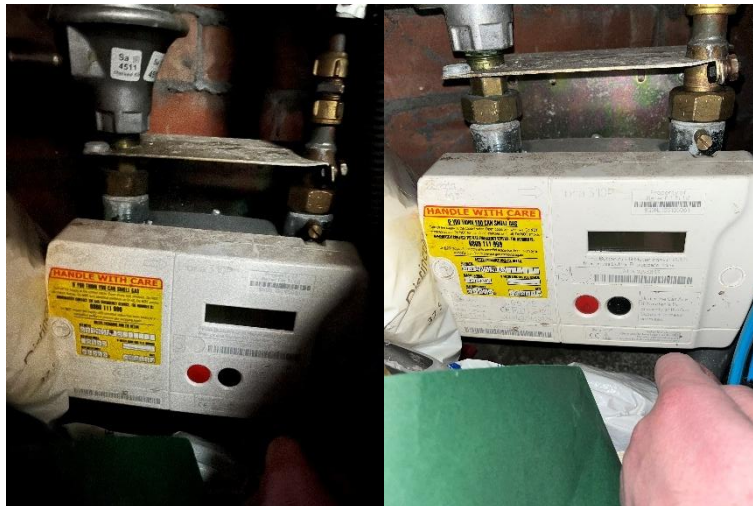
The gas meter was located internally within the under-stair cupboard. At the time of inspection, the meter display did not operate and should be checked by a competent person

3

There was not a gas safe certification available at the time of our inspection. Due to the potential of serious harm and injury resulting from a gas fault or carbon monoxide poisoning, the condition report has been scored as a three. The score is to emphasise the importance of obtaining a current gas safe certificate. All gas-enabled appliances and all gas fittings must be checked by a registered gas safe engineer before the exchange of contracts.

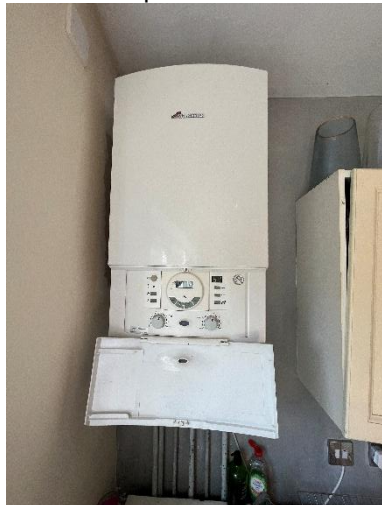
We have not undertaken any tests of the system and cannot comment on its full working order.

There was not a current boiler service certificate available at the time of our inspection. It is advisable before the exchange of contracts to obtain a boiler service certificate which includes a condition report on all radiator components.

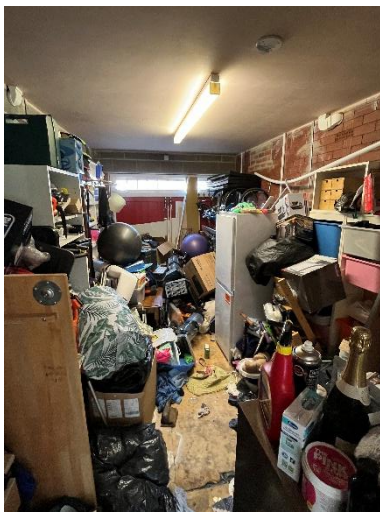
The garage was heavily furnished with storage shelves and household items; therefore the garage could not be inspected in its entirety, NI

3

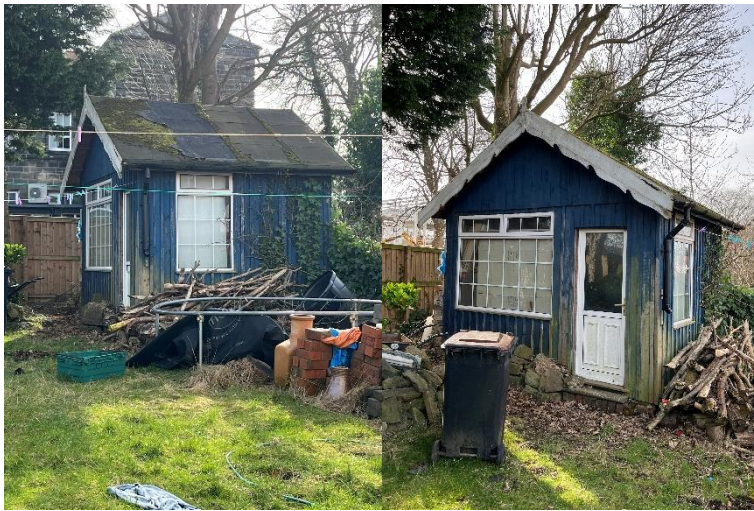
The shed has an electrical power supplied provided from the main house, the feed cable is surface laid across the garden and should be buried to a suitable depth to prevent risk to health

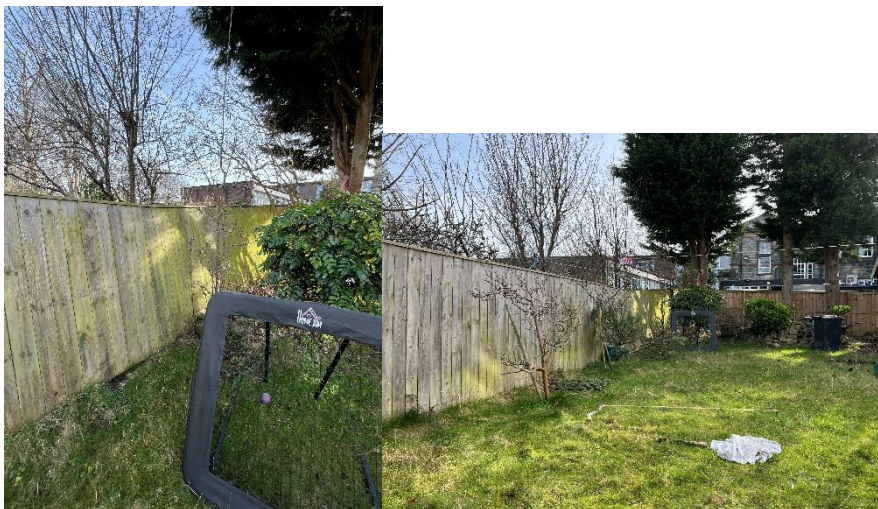
The rear elevation is enclosed with timber posts, timber rails and timber palings. The fence line is poor condition with evidence of failure to all boundaries. The fence timbers need to be maintained, repaired, and replaced as necessary.

**2**
